# Beaver Creek Habitat Improvement and Sediment Reduction Project

July - August 2022

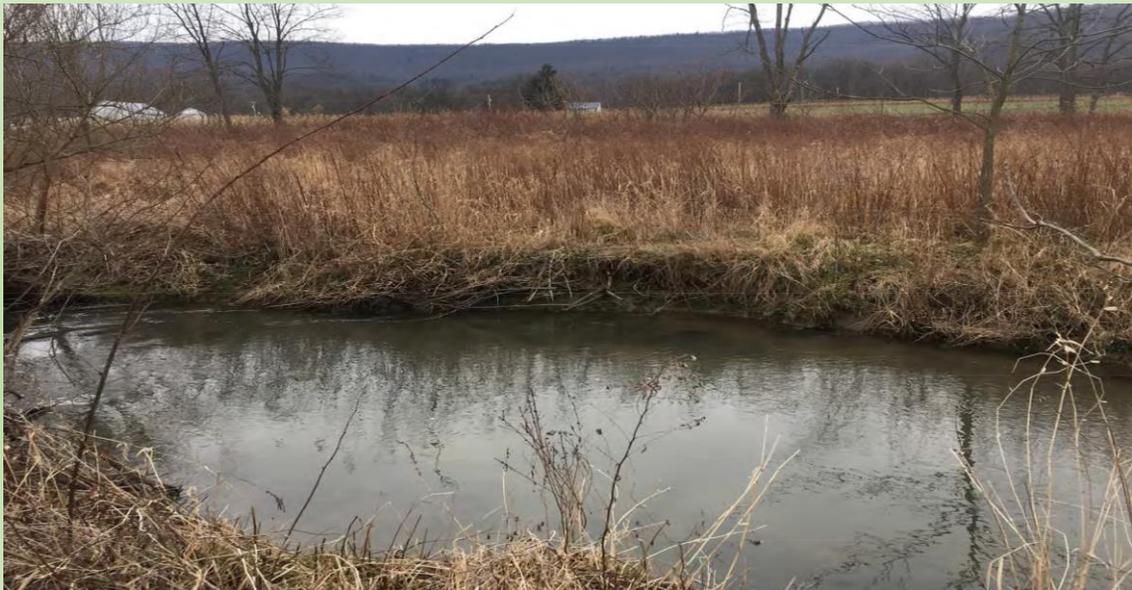
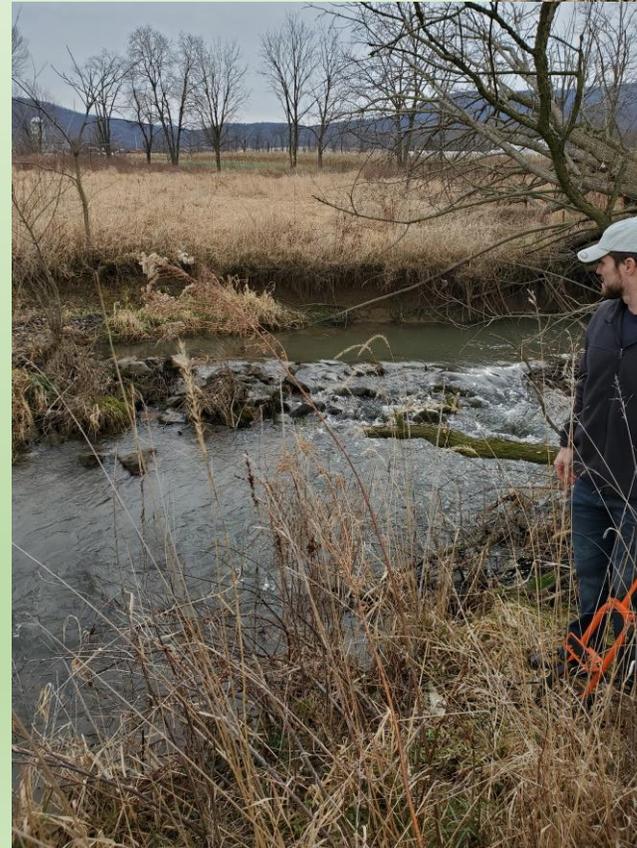
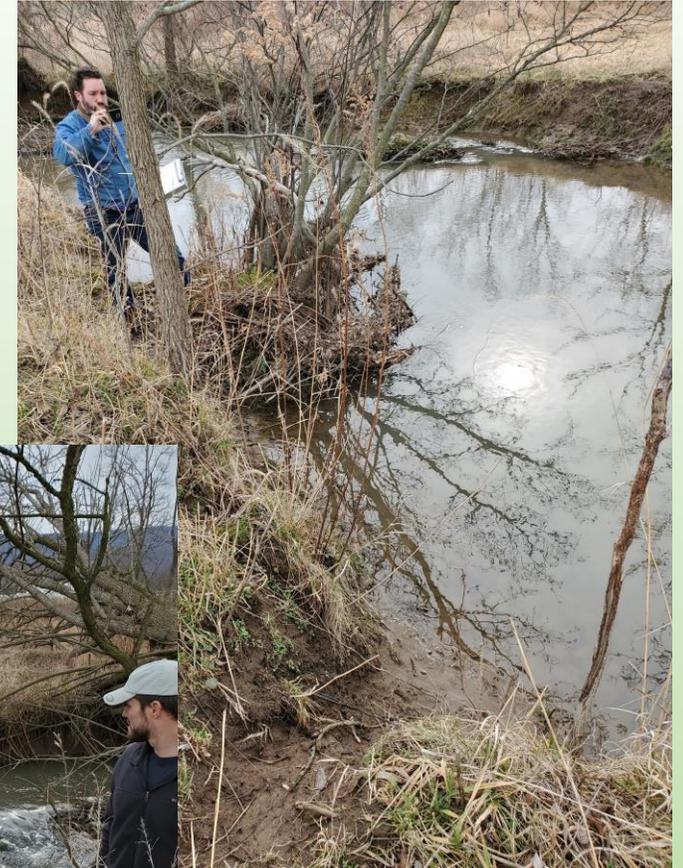
In January 2020, BCCD returned with Trout Unlimited stream habitat specialists to assess the possibility of a project on approximately 1300 feet of stream

Photos from January 13 visit with Trout Unlimited staff.

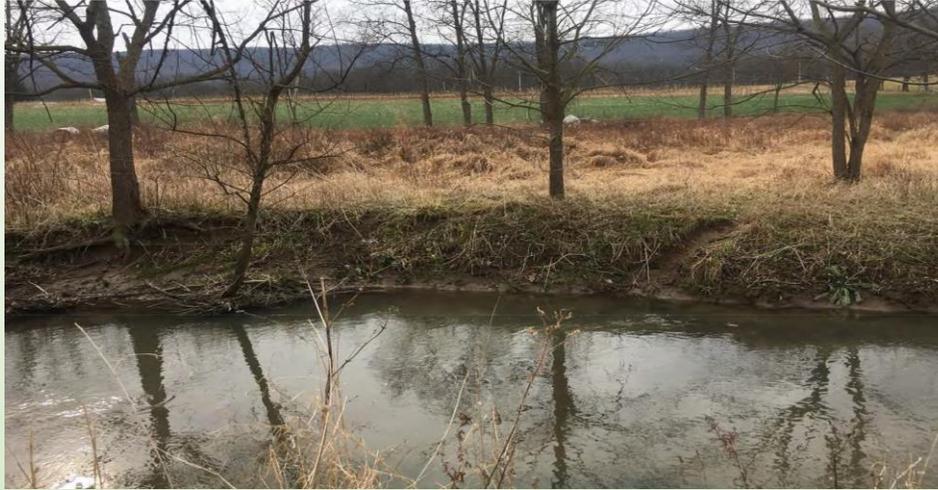
Construction began on July 28, 2022, at the upstream part of the project (above the footbridge). Three log-framed stone deflectors were installed along the eroding southwest bank.

Photos of eroded streambank, ↑  
January 13, 2020 ↓

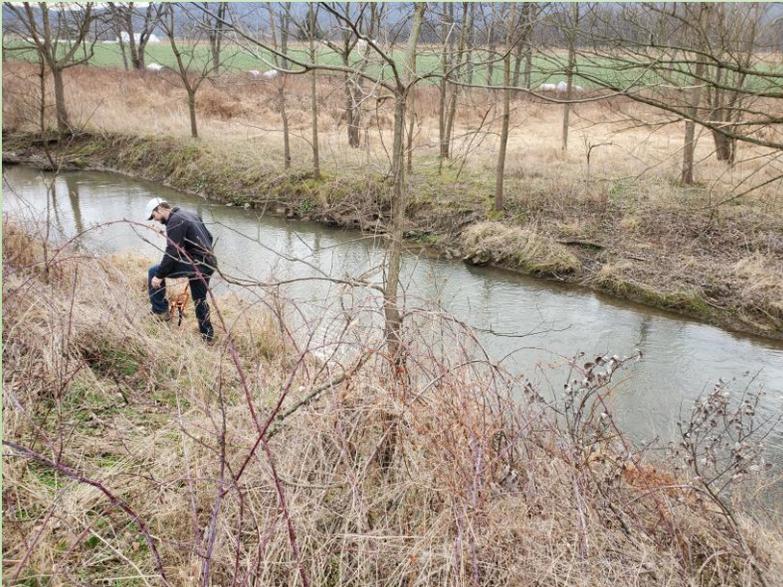
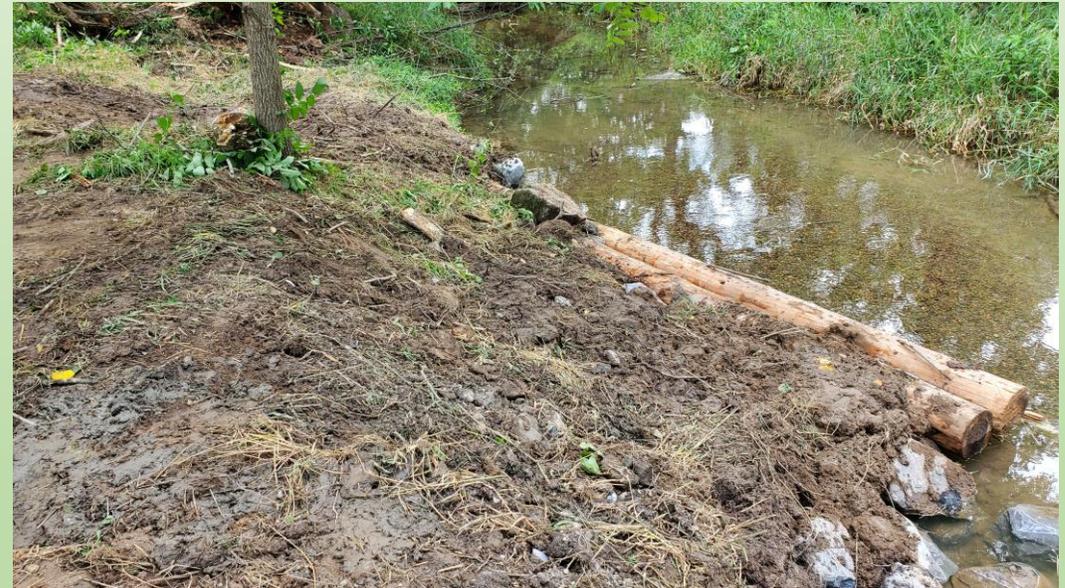
View of a completed deflector, before seeding and mulching, July 28, 2022.

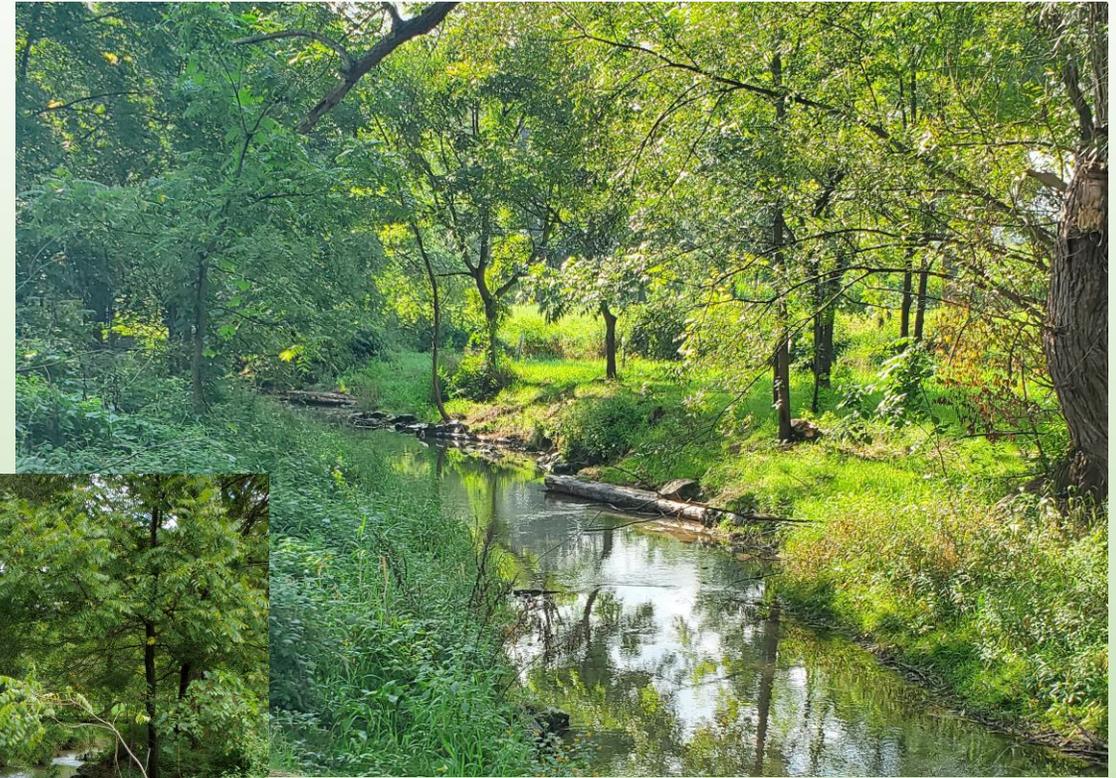
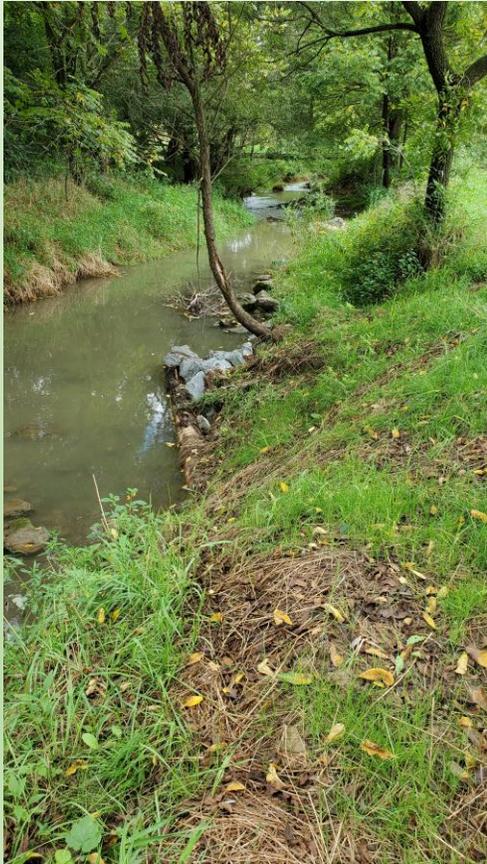
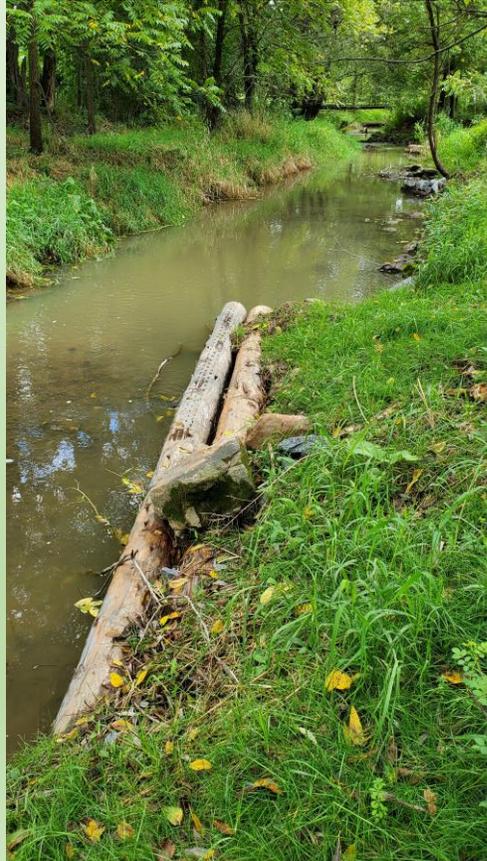
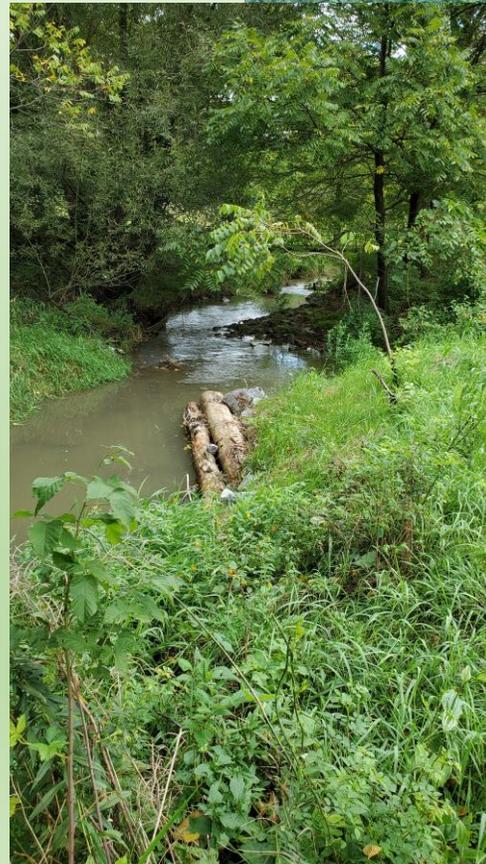
These photos were taken more than a month after the initial work on this section of the project, and after heavy rains in the area, hence the turbidity. The areas with shorter grass were disturbed during construction and were seeded and mulched when work was complete.

These photos show the 3 deflectors that were the first devices placed in the last days of July. (Photos taken September 8, 2022)

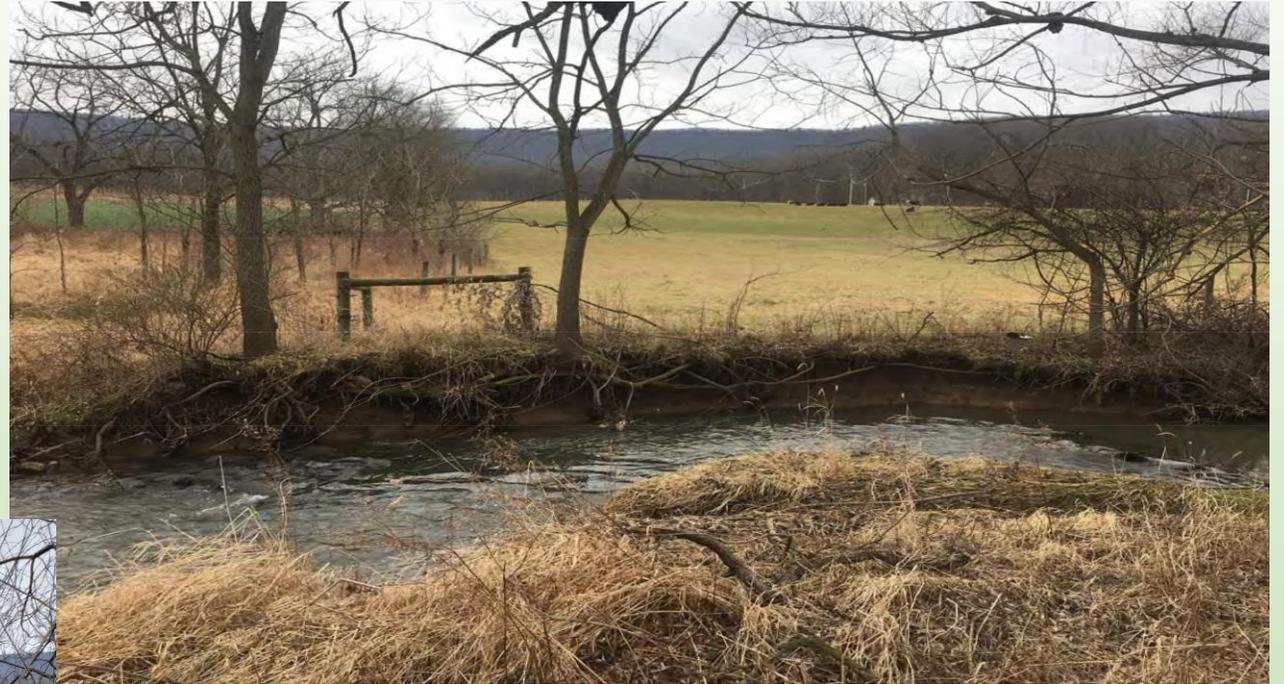
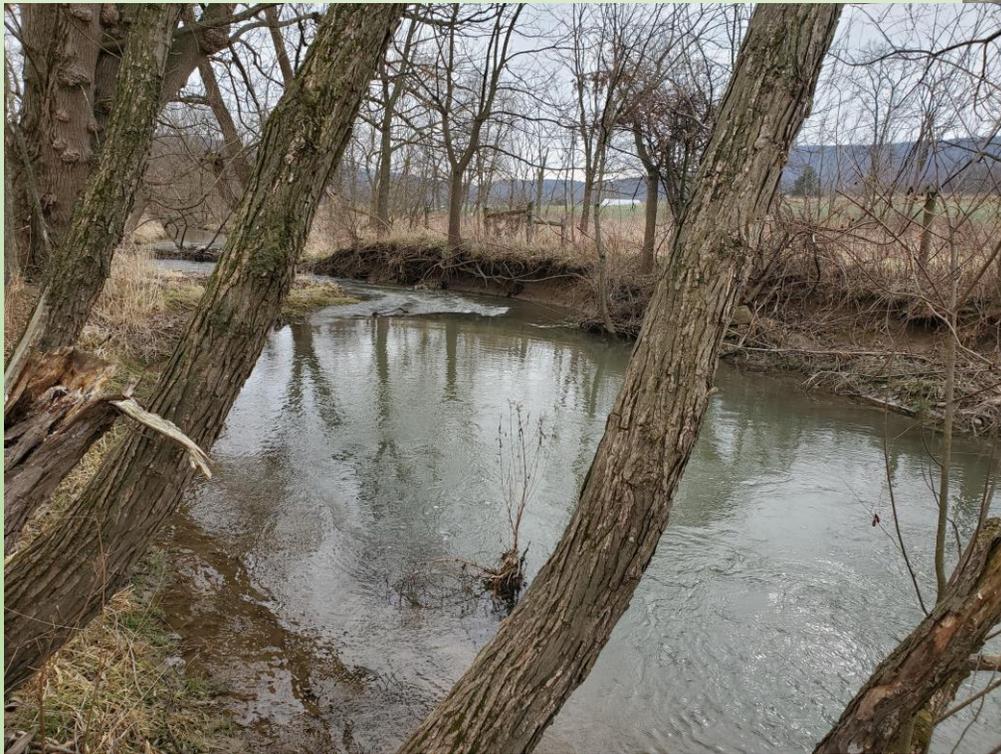
These 2 photos from 2020 show the undercut bank where the modified mudsill would be constructed. At the time of construction, the erosion had undercut the stream bank as far as the fence wire and threatened the fence posts.

Also constructed in the upstream portion of project were 2 small single log vanes and a modified mudsill.

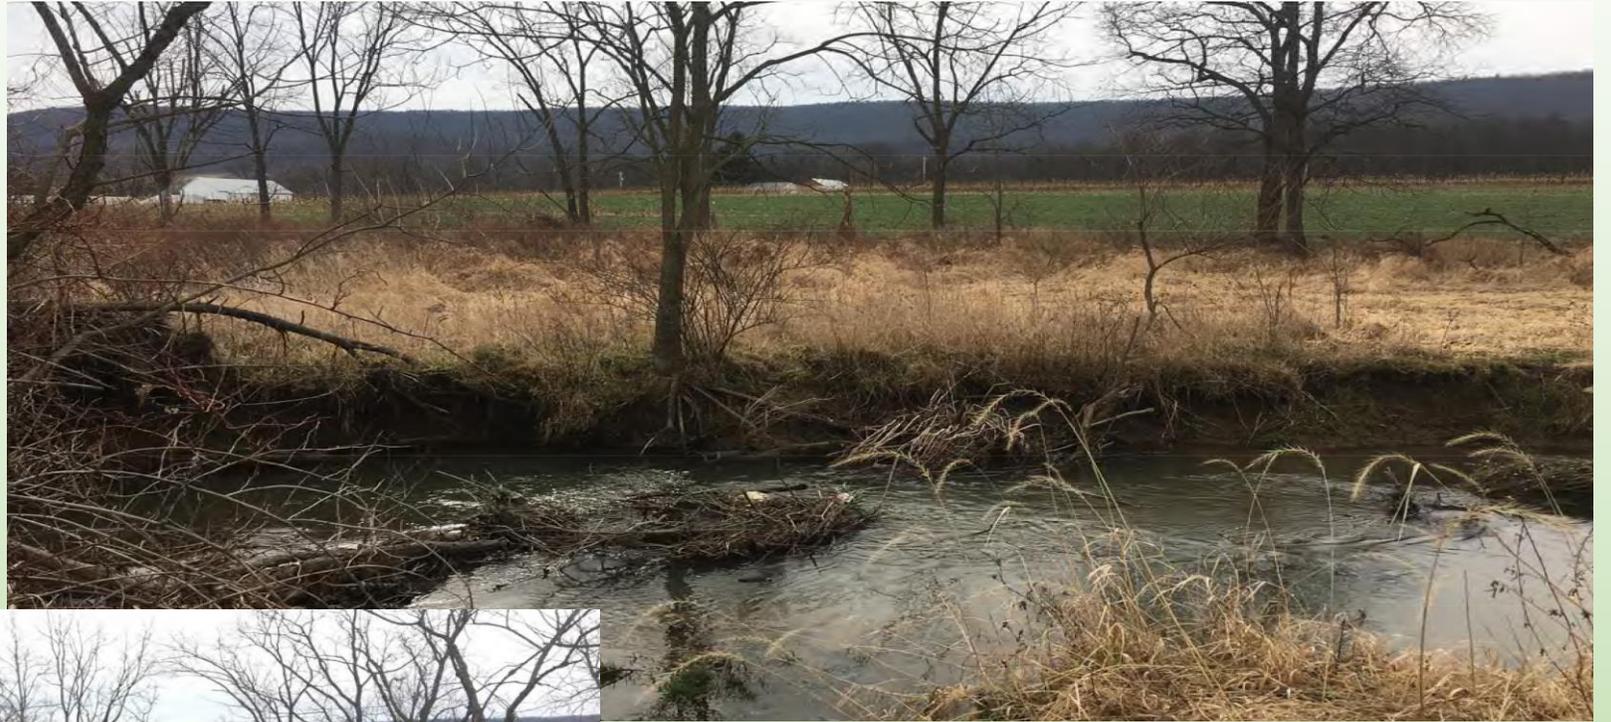
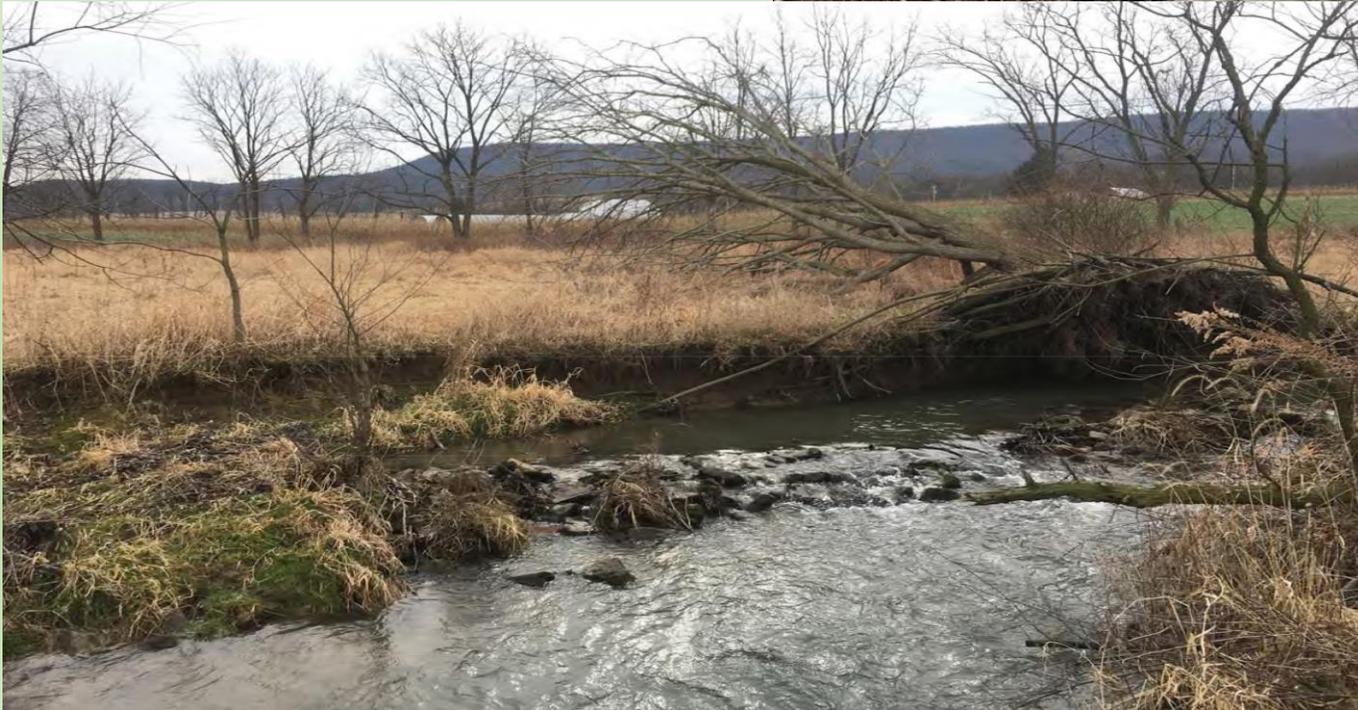
Also constructed in the first days of August, just below the series of vanes and deflectors, was a larger modified mud-sill spanning an outside bend of the northwestern bank. This was one of the most significantly eroded areas.

The photos here are from January 2020 and the fallen tree seen in the photo at right was removed prior to work commencing in 2022.

Just below the site in these photos, the creek made a reverse meander where erosion exposed another undercut began, though less severe.

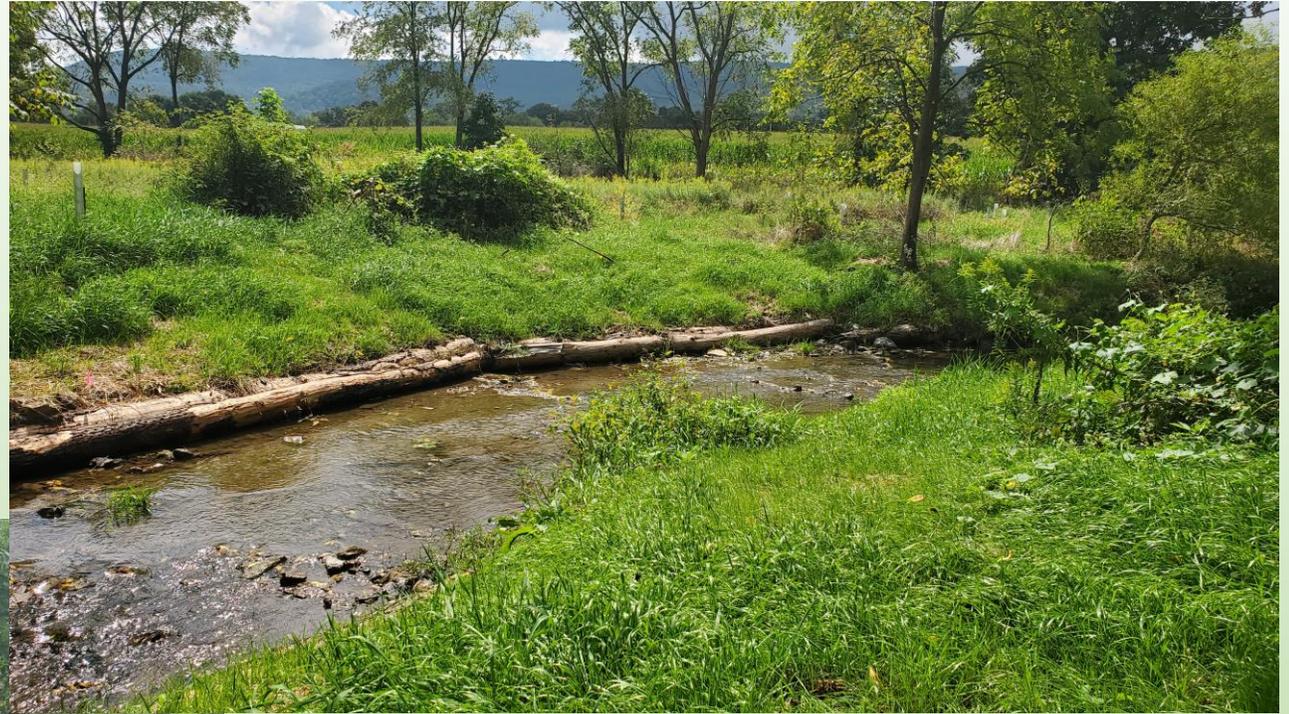
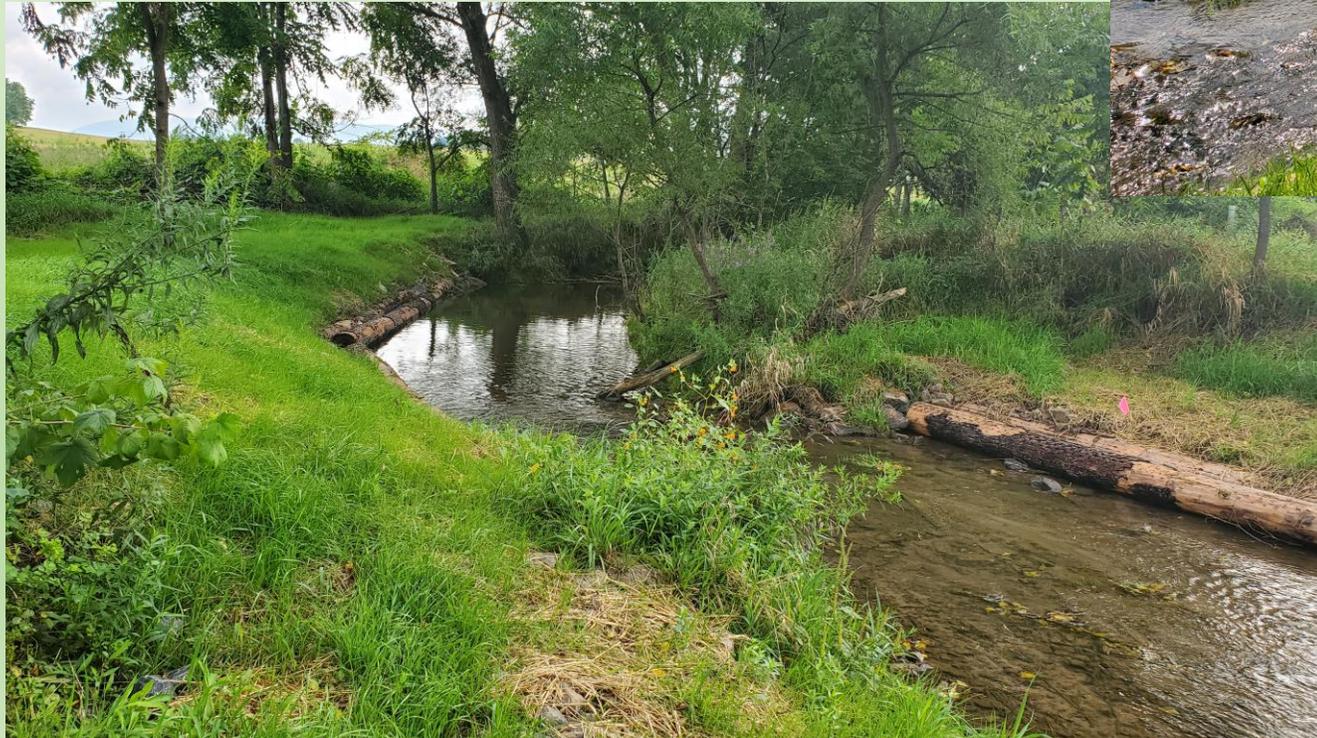
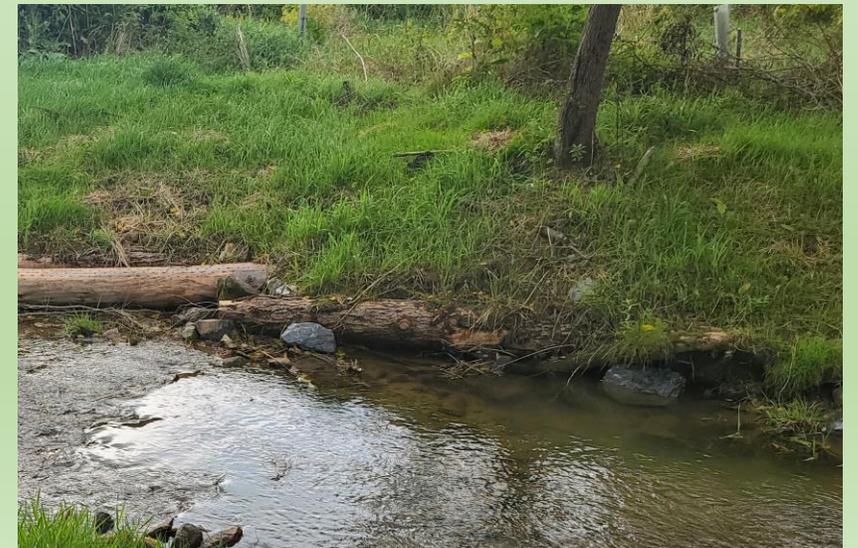
After the tree in the preceding photos fell, bank erosion widened the stream considerably and exposed a mid-channel bar of stone that previously form the toe of the former streambank. When the modified mud-sill seen in these images was installed, the face logs were situated to approximate the location of that previous bank toe.

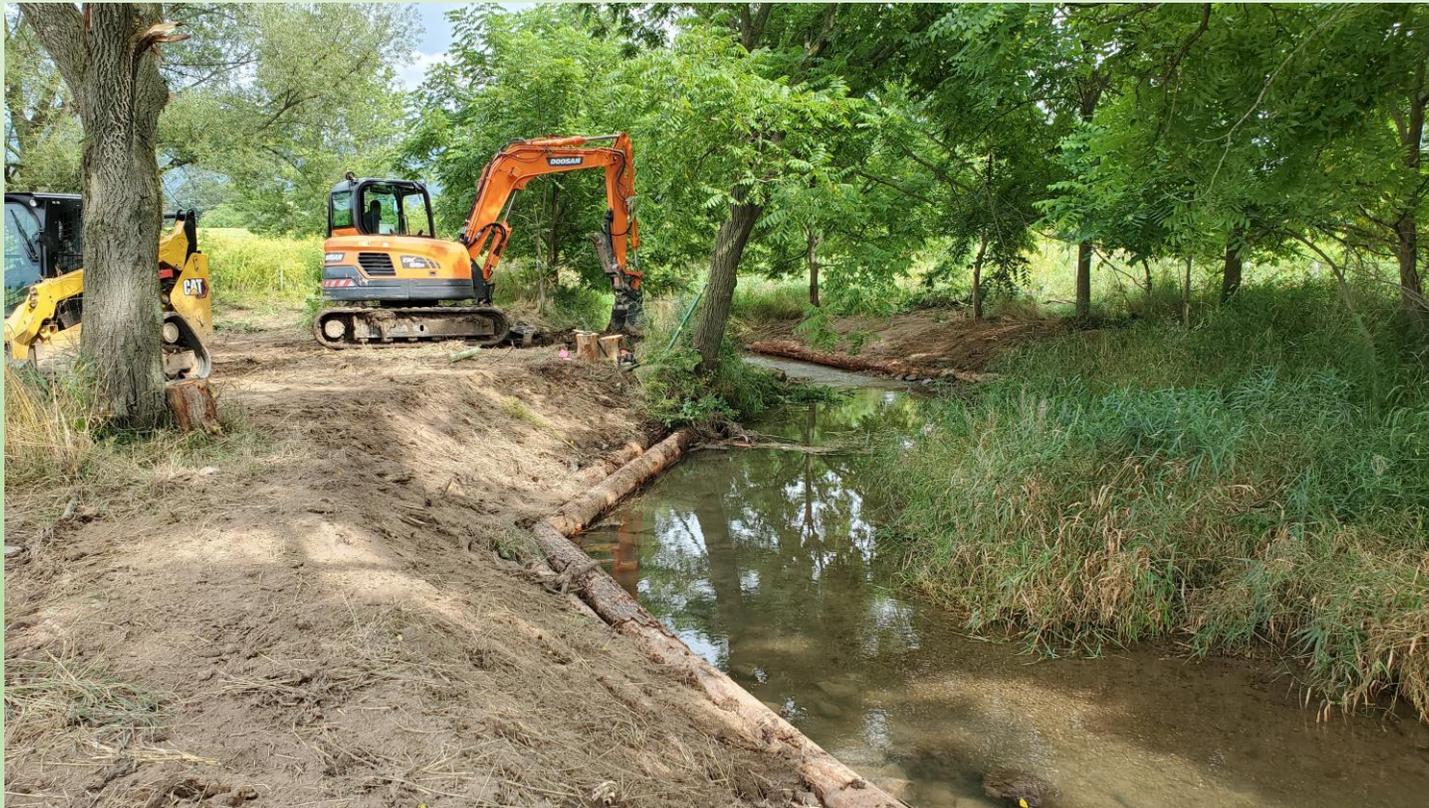
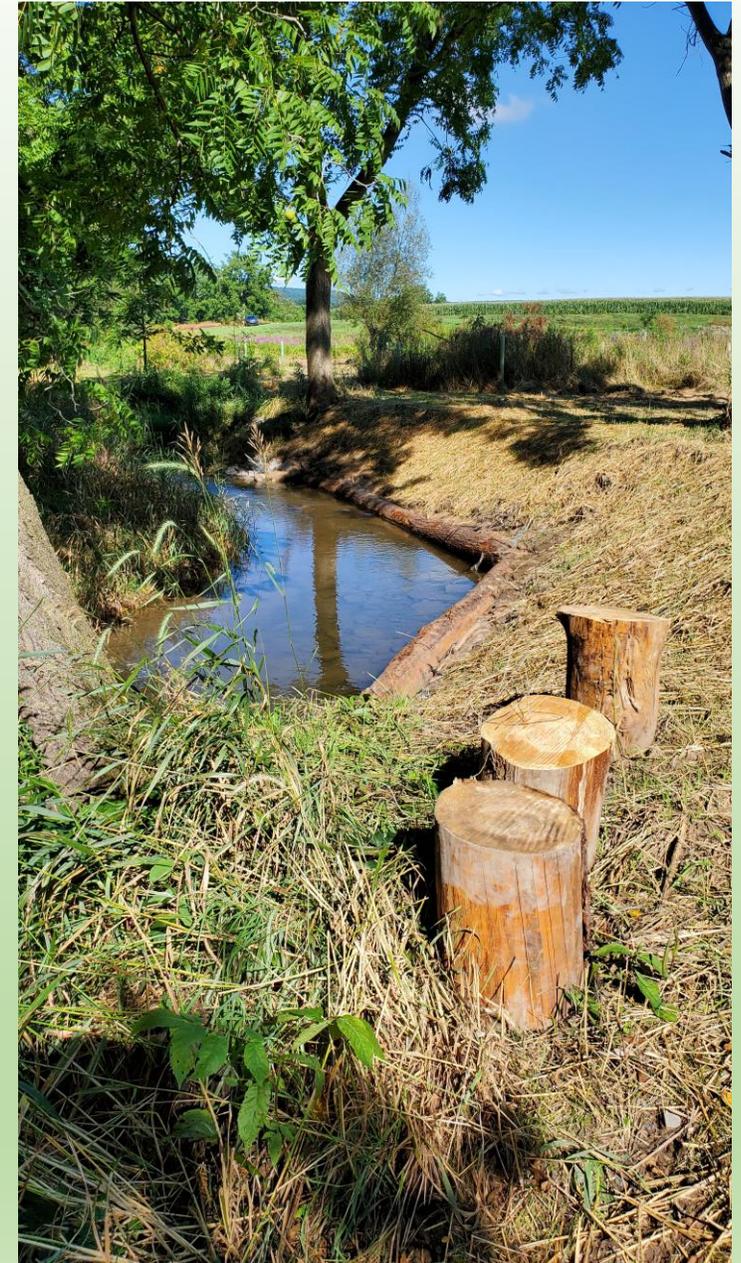
Erosion was occurring on most of the meanders proceeding downstream. Modified mud-sills, often with wing-logs, were installed to stabilize the stream banks.

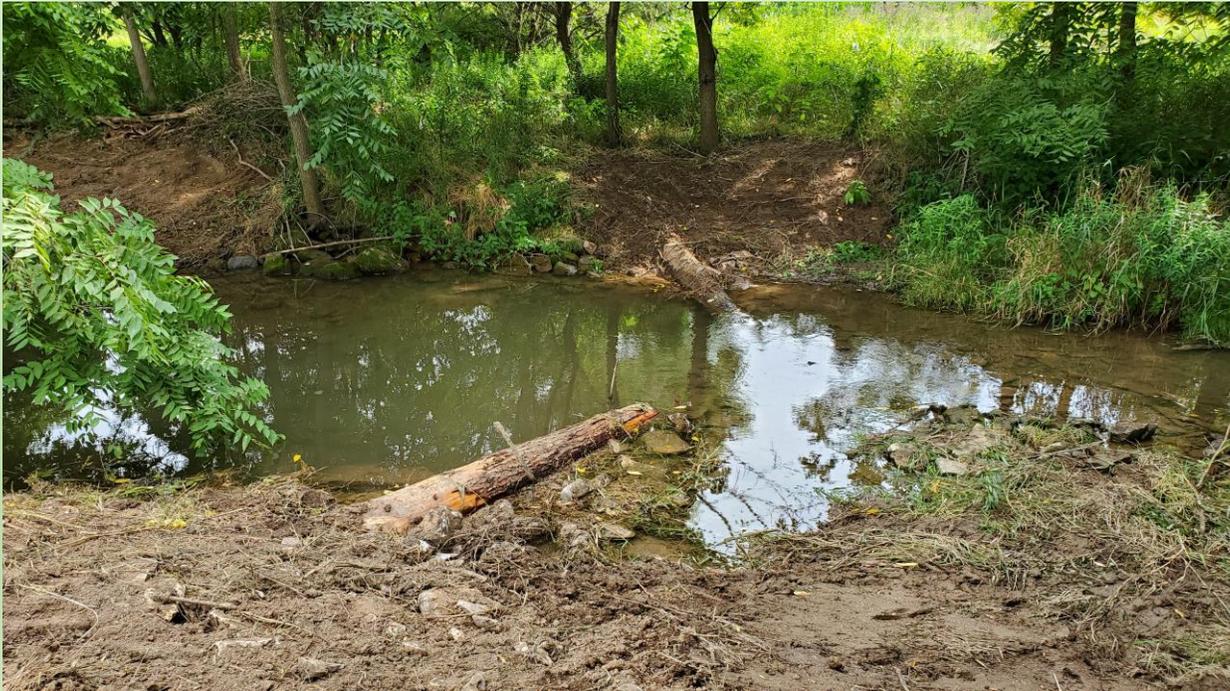
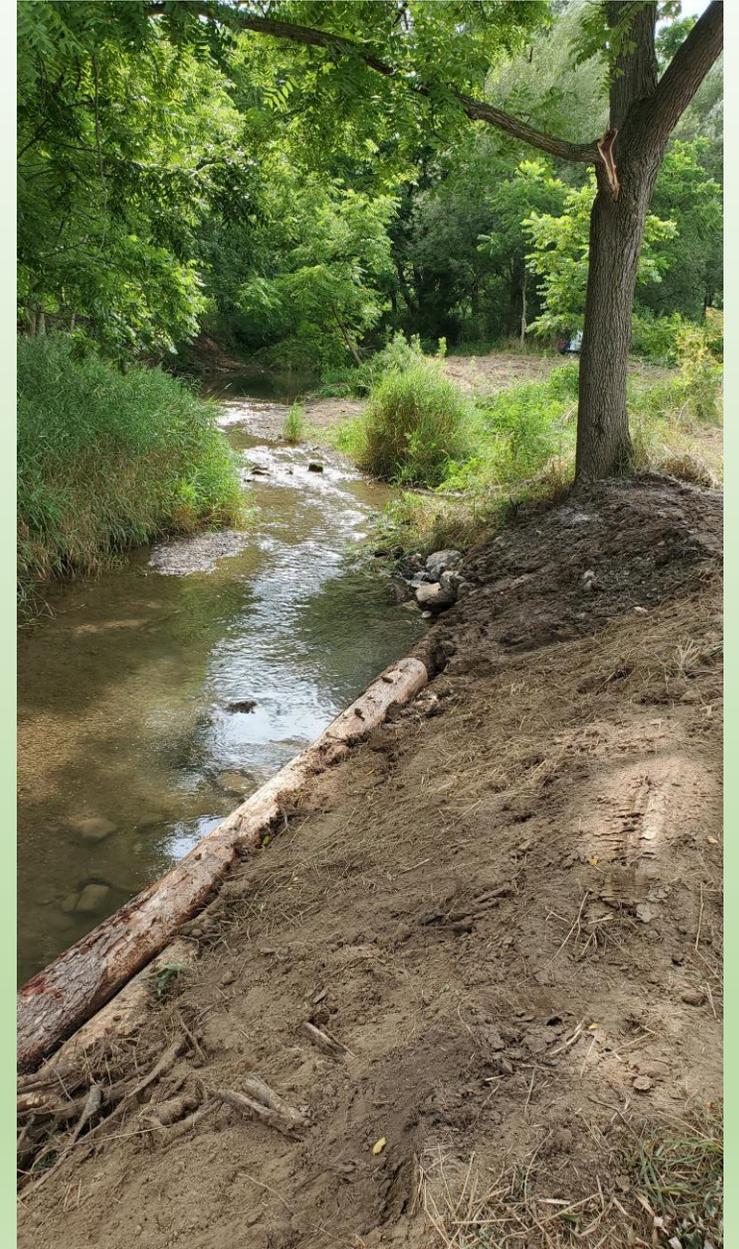
At another location on the stream the channel was narrow where it entered a small, deeper pool that was significantly wider and slower. Exiting the pool, the channel again narrowed as it flowed over a riffle area. An eroded bank, partially hidden by the small walnut tree on the right of the photo below was addressed with a log-framed rock deflector, while a pair of opposing log vanes at the head of the pool were installed to center the flow and flush sediment through the mid-channel. The photo at right shows this pool in the background.

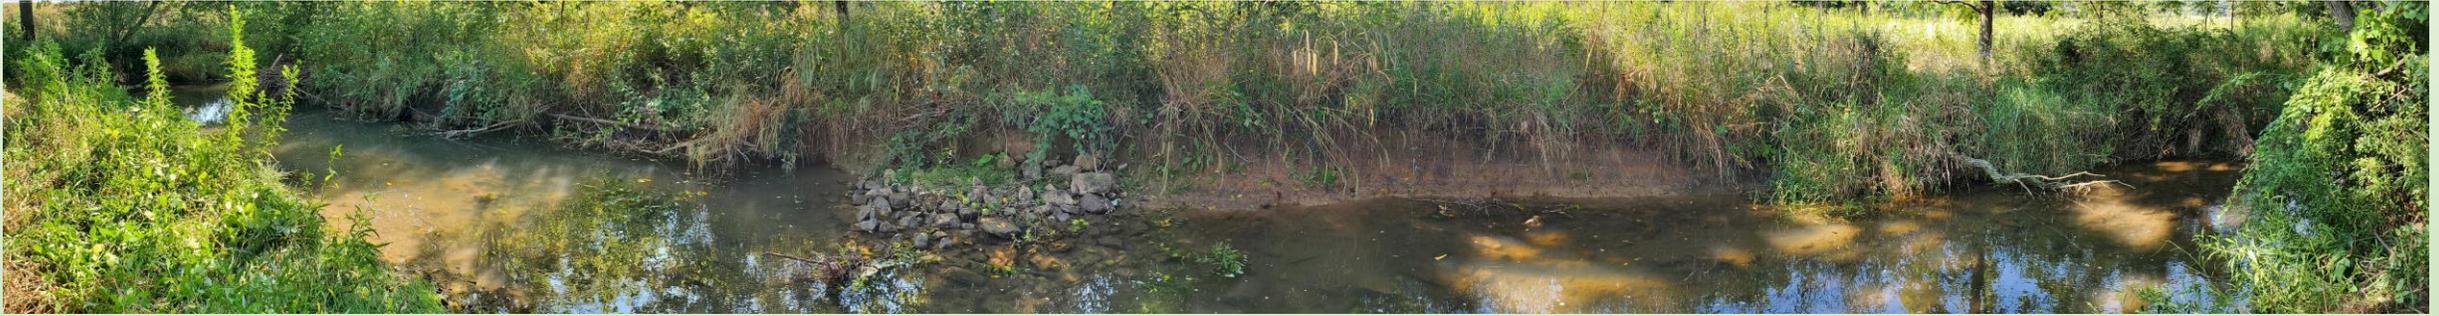
This panorama view of the last larger eroded site to be stabilized with a multi-section modified mud-sill was created in Photoshop by merging multiple photos. It is a distorted view in that what appears to be a straight section of stream is really a sweeping bend with an eroding outside bank.

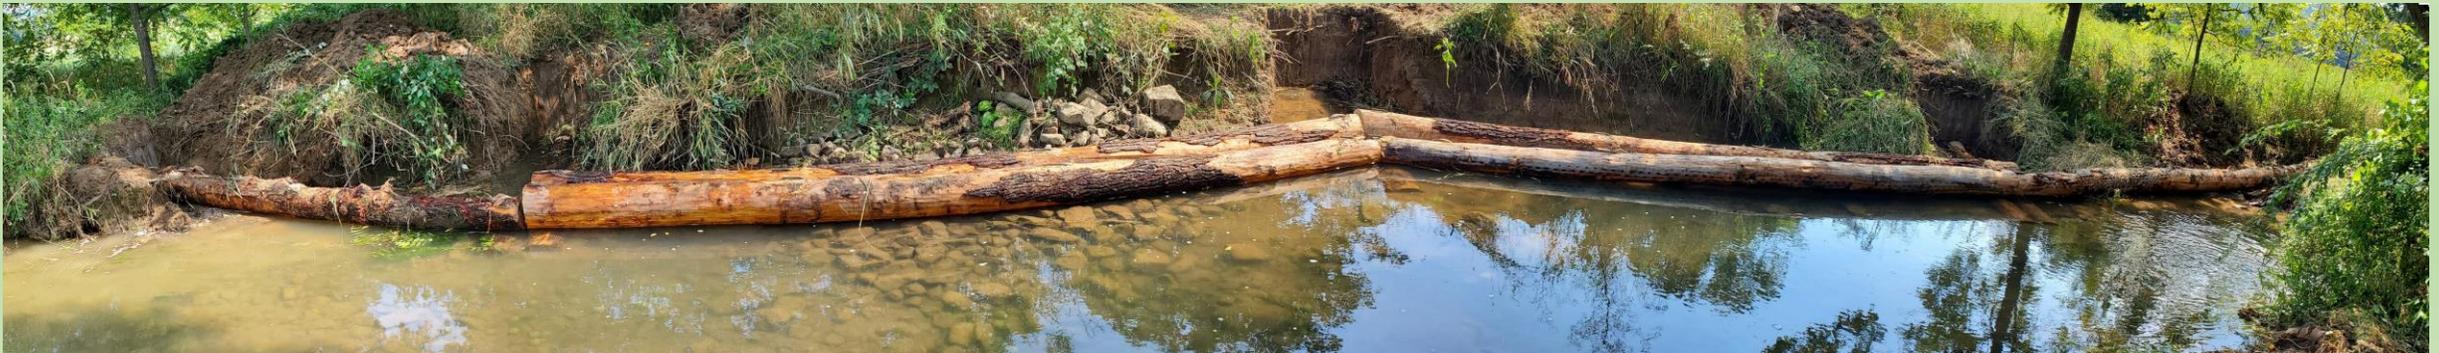
Similarly, the photo below is a multi-shot composite showing the logs comprising a 2 section modified mud-sill with wing logs both upstream and downstream. Double sill logs are visible in three of the trenches.

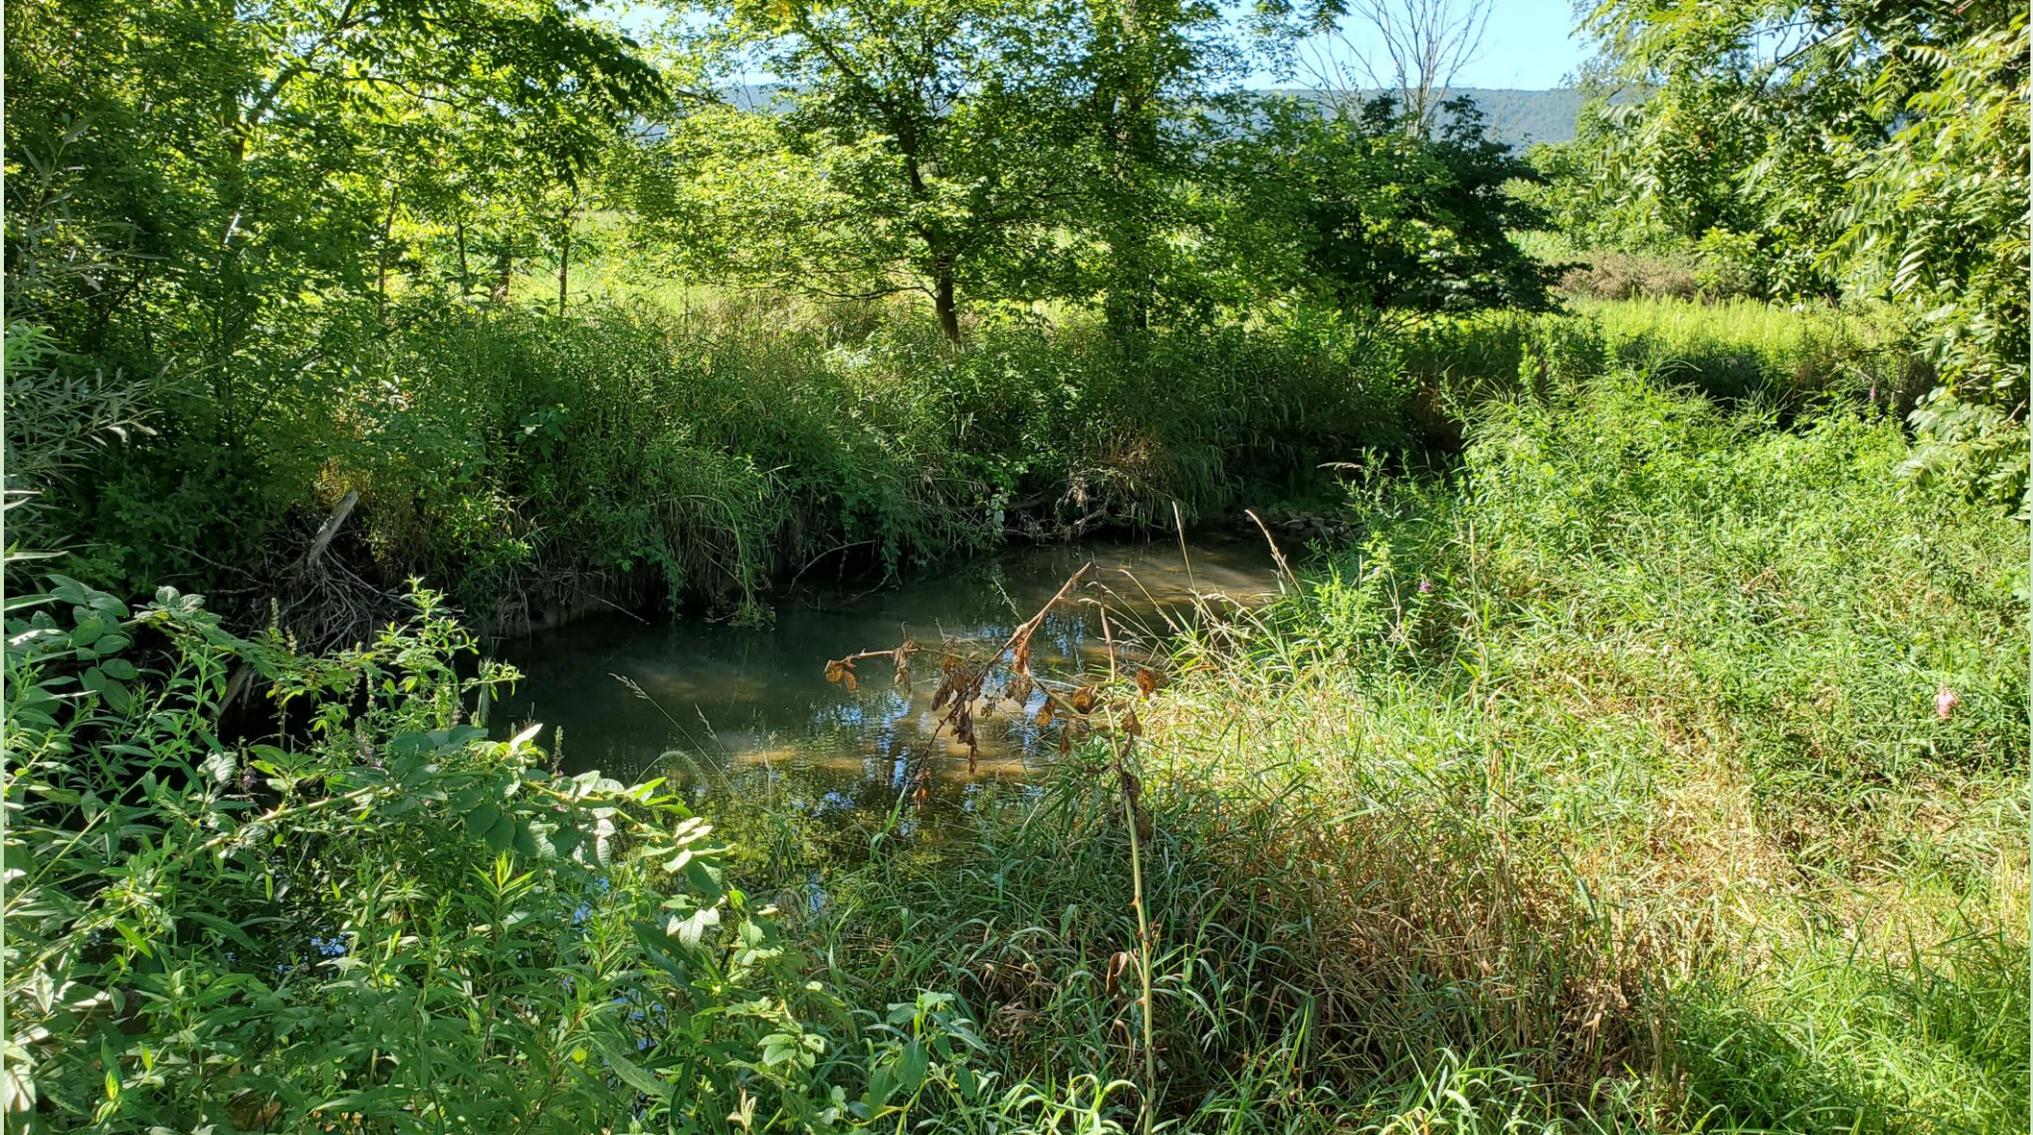
This photo shows the streambank at the far left of the composite views on previous slide. It was inserted here to show the nature of the streambank in most areas worked; much harder to spot eroding banks than in January.
