# Beaver Creek Habitat Improvement and Sediment Reduction Project

July - August 2022

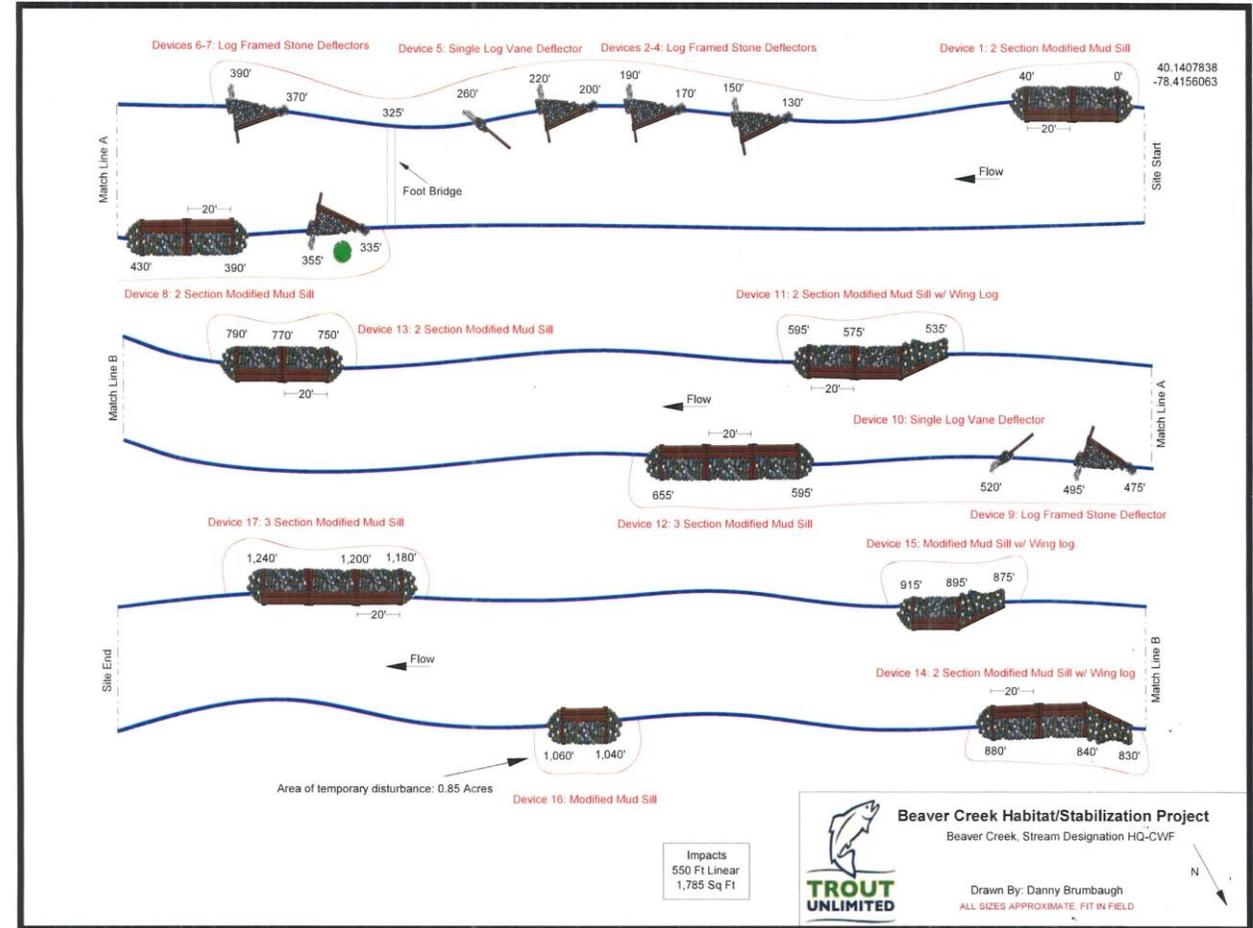
The National Trout Unlimited staff provided a plan that included a drawing of device locations, detail drawings of the device types, a materials list, and estimates of impacts and reductions. The project was estimated to cost just over \$36,000, stabilize about 1240 feet of streambank, and reduce sediments loads by 16,680 pounds or 8.34 tons per year.

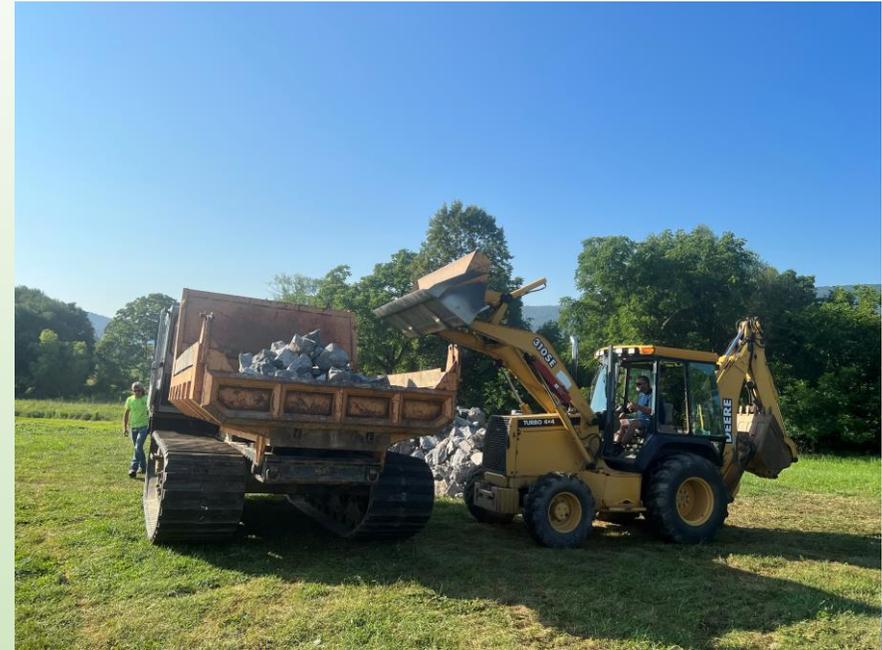
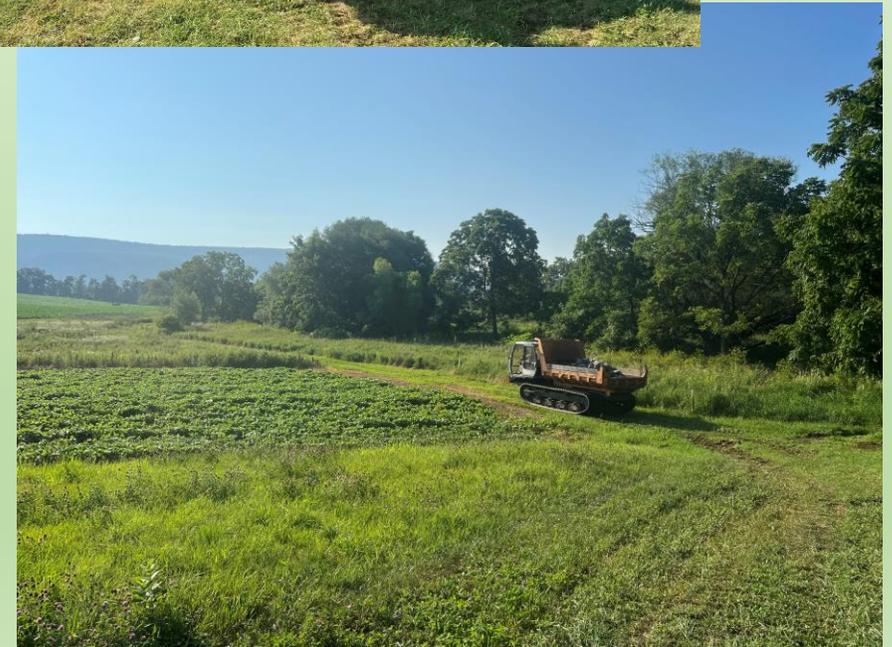
After the stone was delivered to the worksite, a loader and track truck were used to stage rock at locations close to where devices would be constructed.

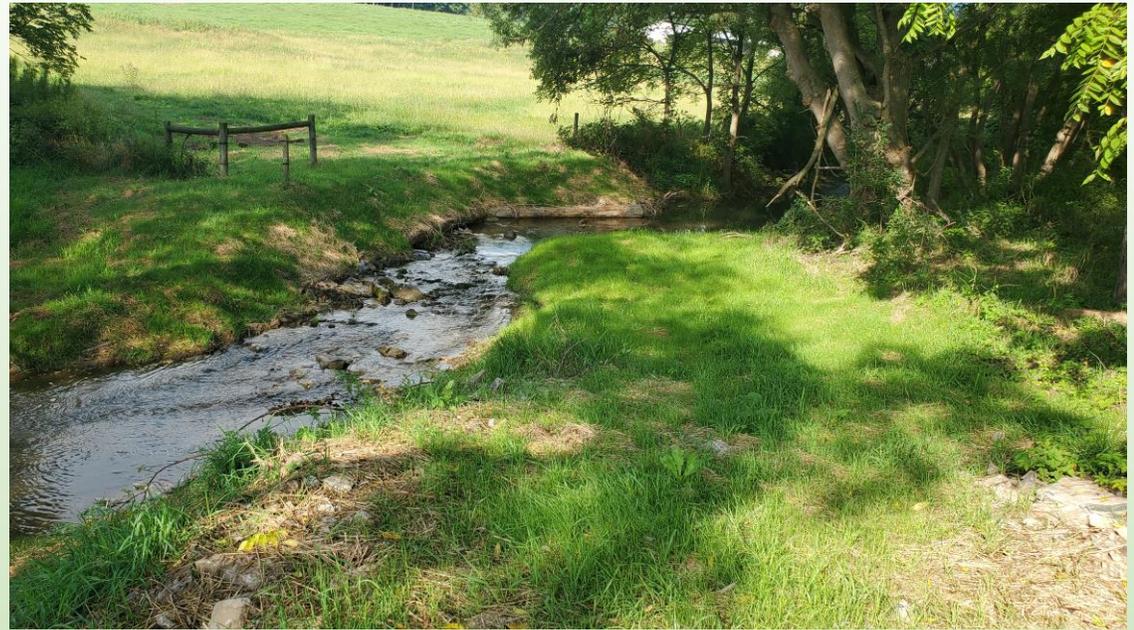
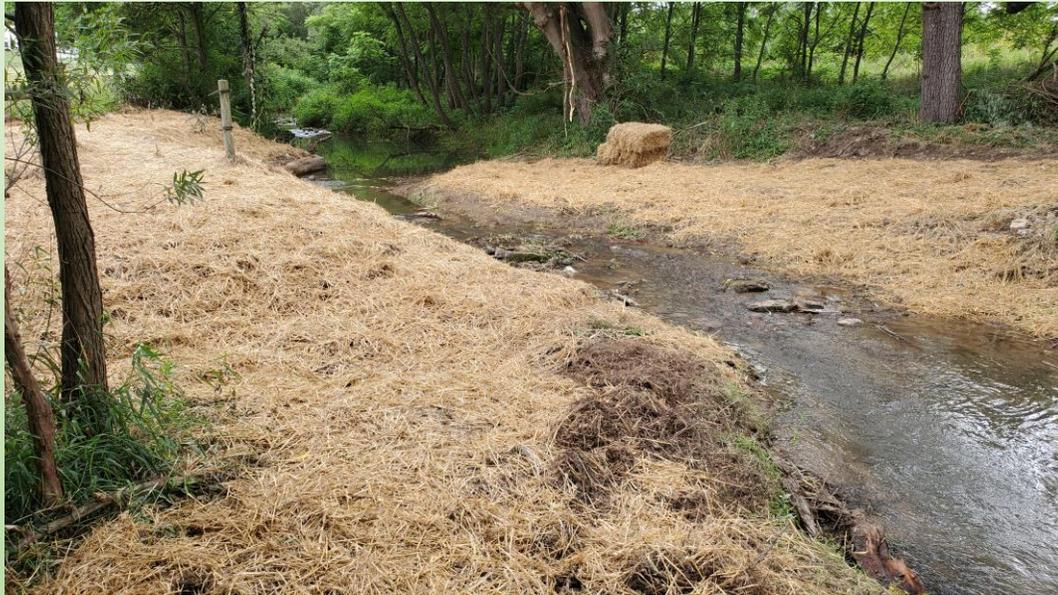
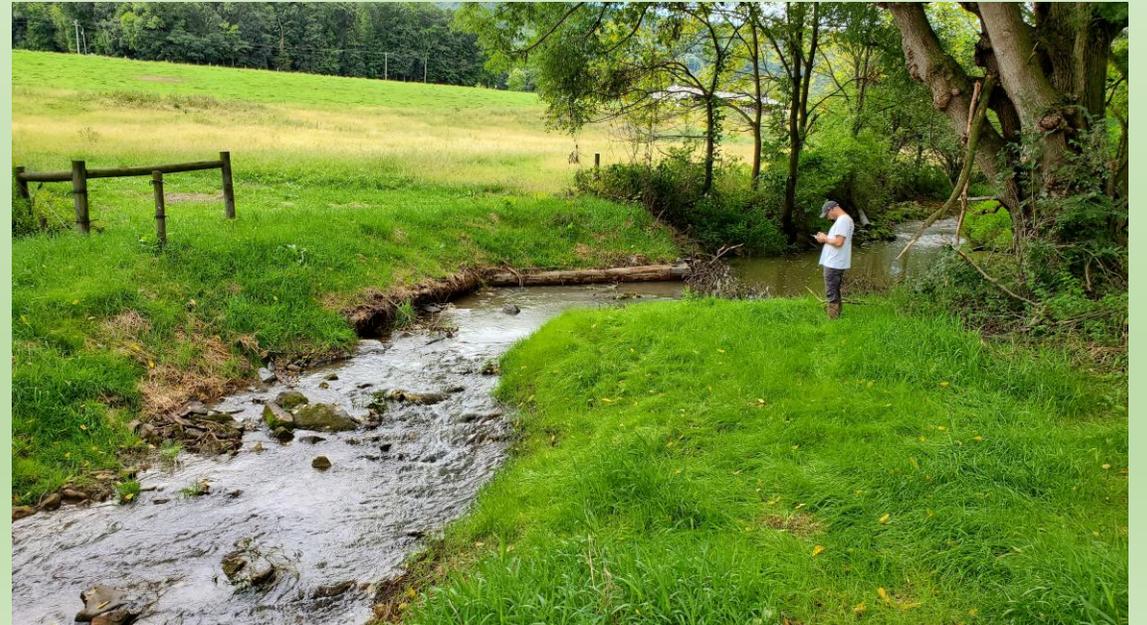
August 27, 2022 →

No photos were taken during construction of this first mud-sill but the image below shows the site when the seeding and mulching was complete.

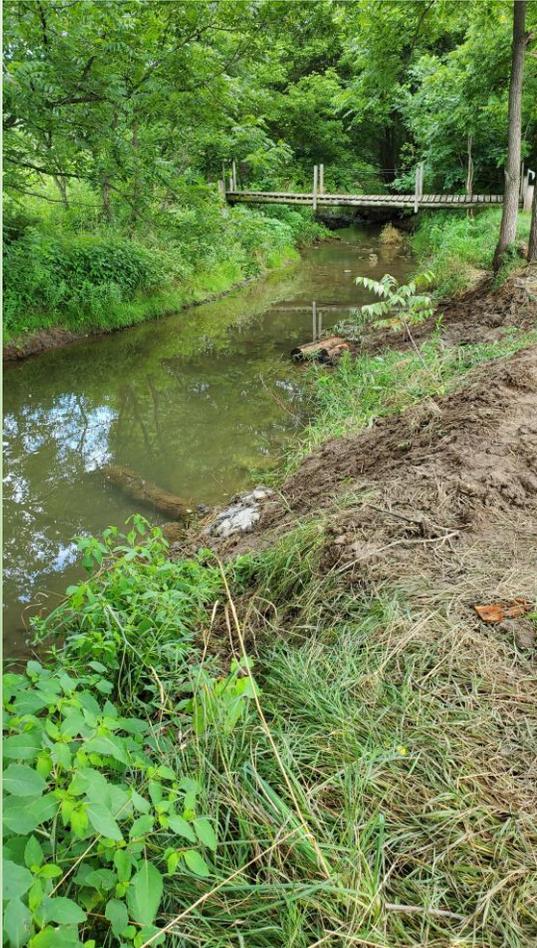
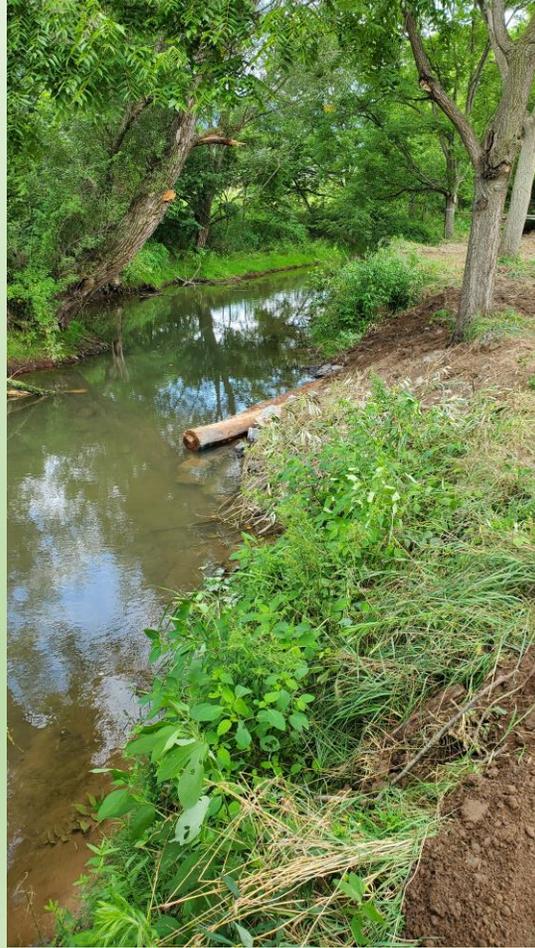
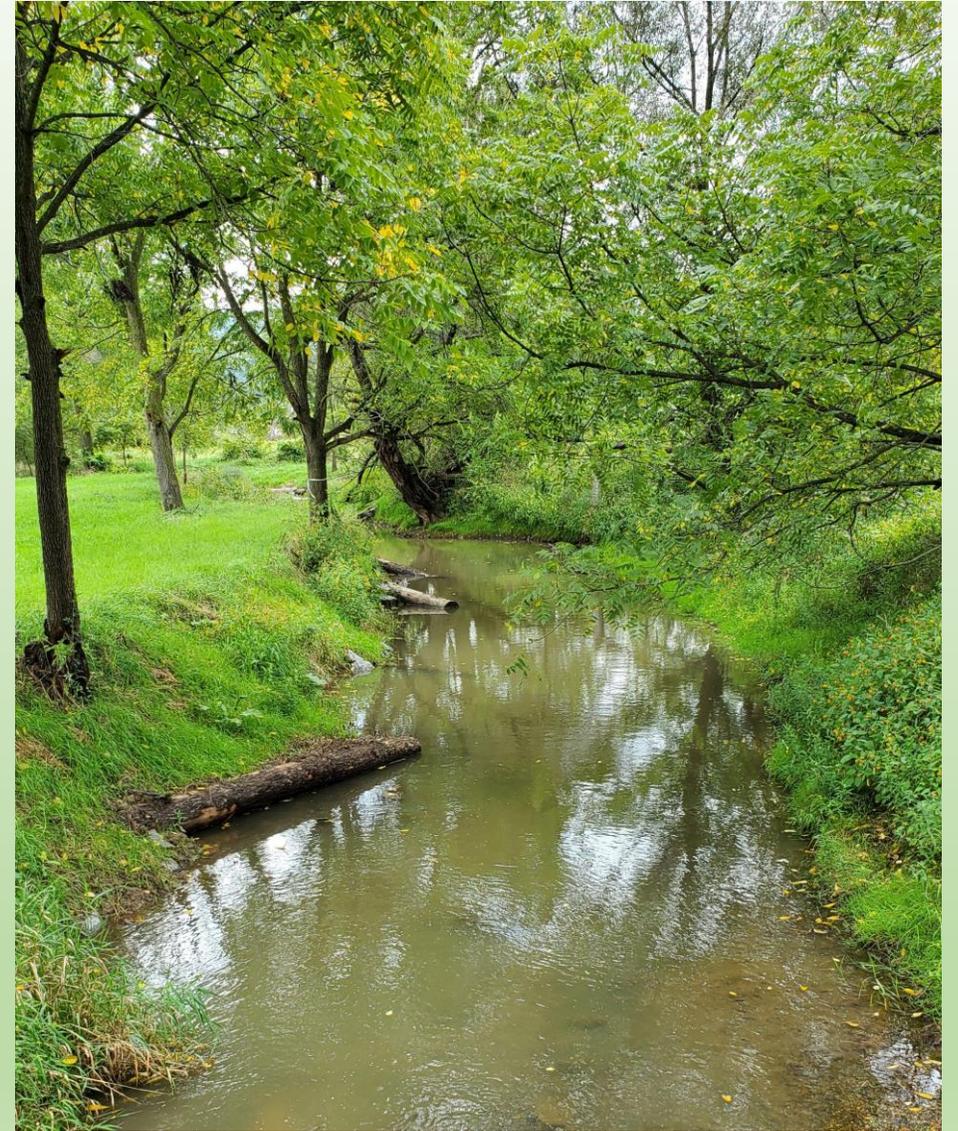
Work below the footbridge began on August 2, with construction of a series of log-framed stone deflectors and log vanes along the southeast stream bank where erosion was occurring. Photos below from August 2.

Photo above taken from footbridge, September 8.

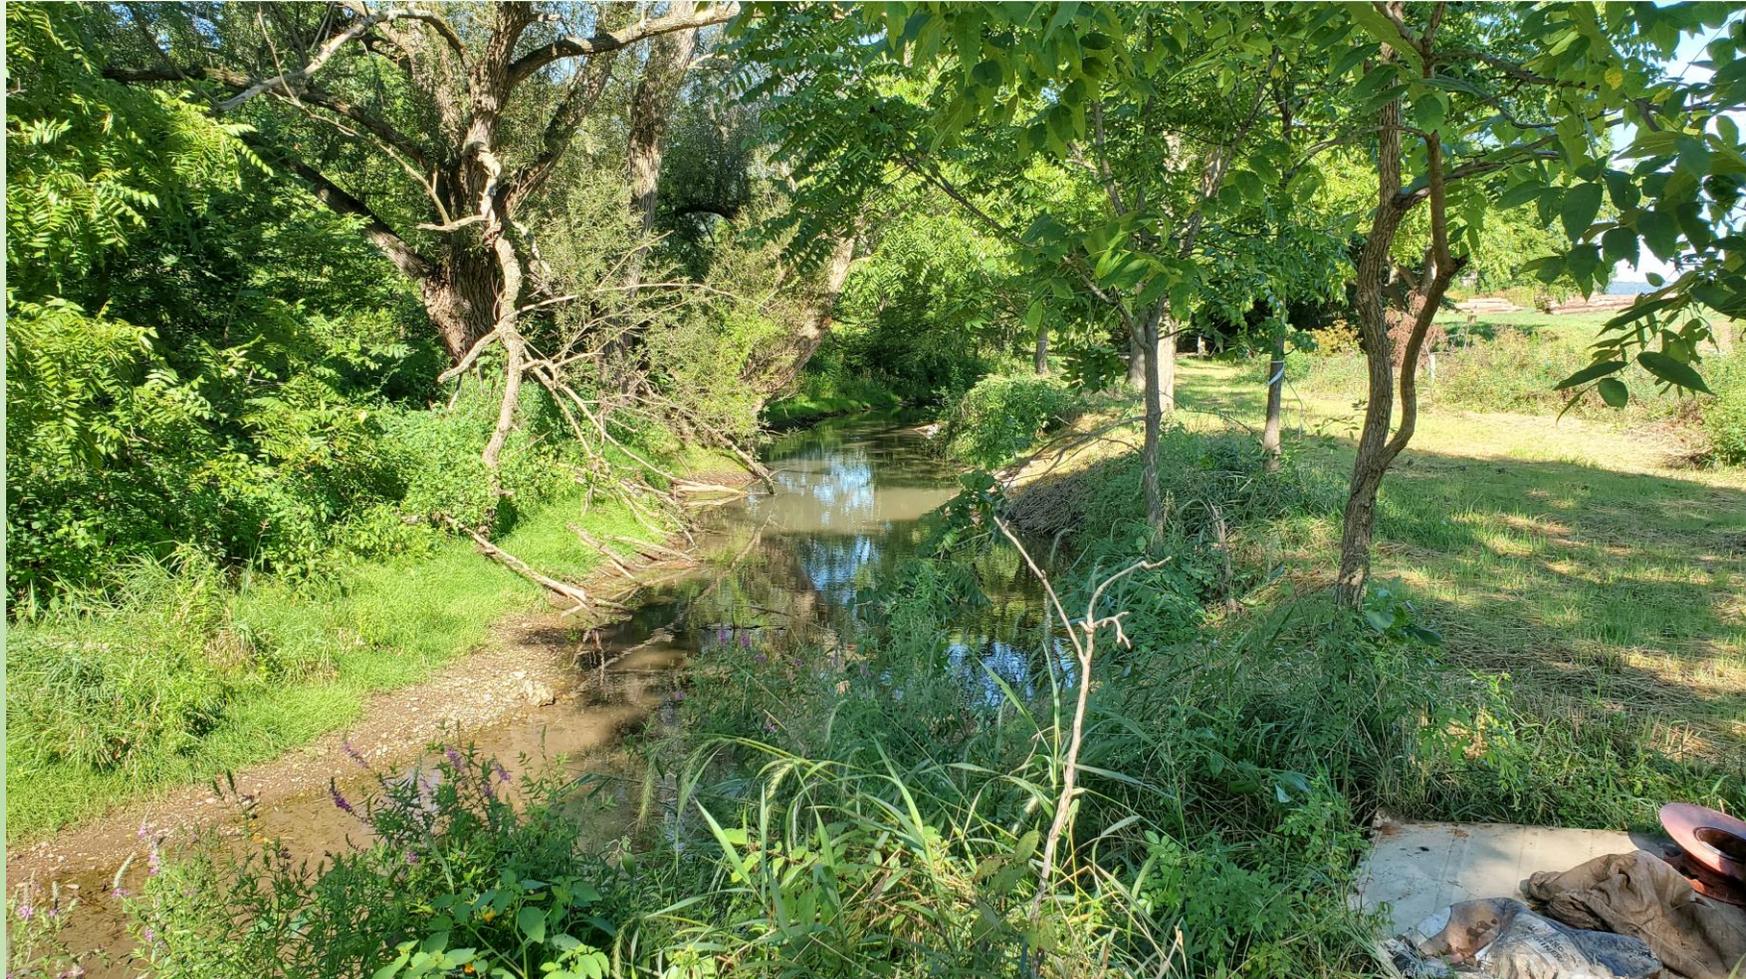
This photo was taken August 12, 2022 during a pause in construction activity. The project site was visited to assess the growth of the grass that had been seeded. This image is included here as the only photo that shows the log stockpile at far right in the background.

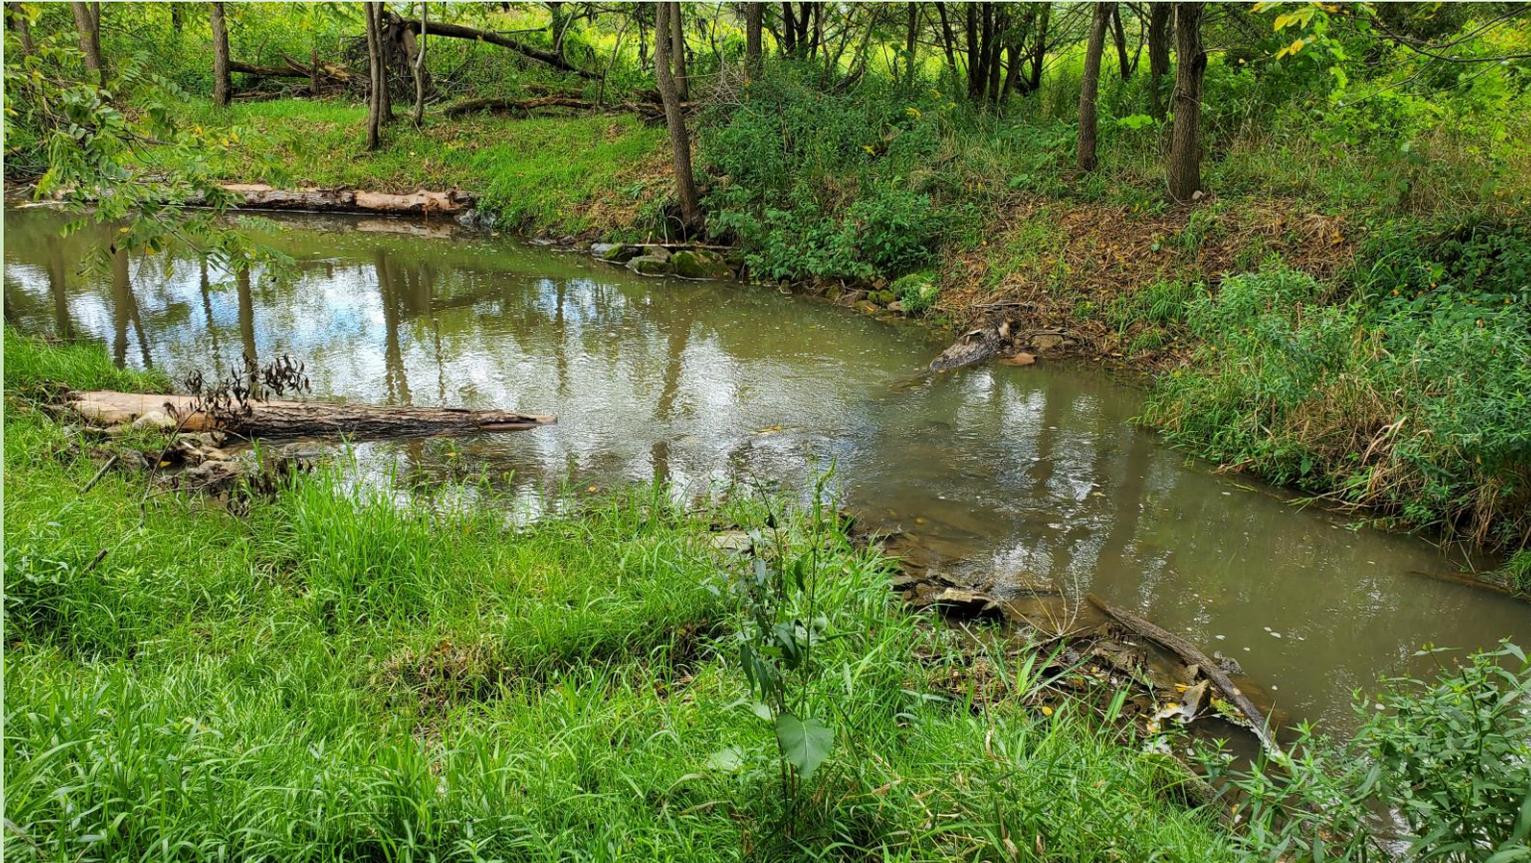
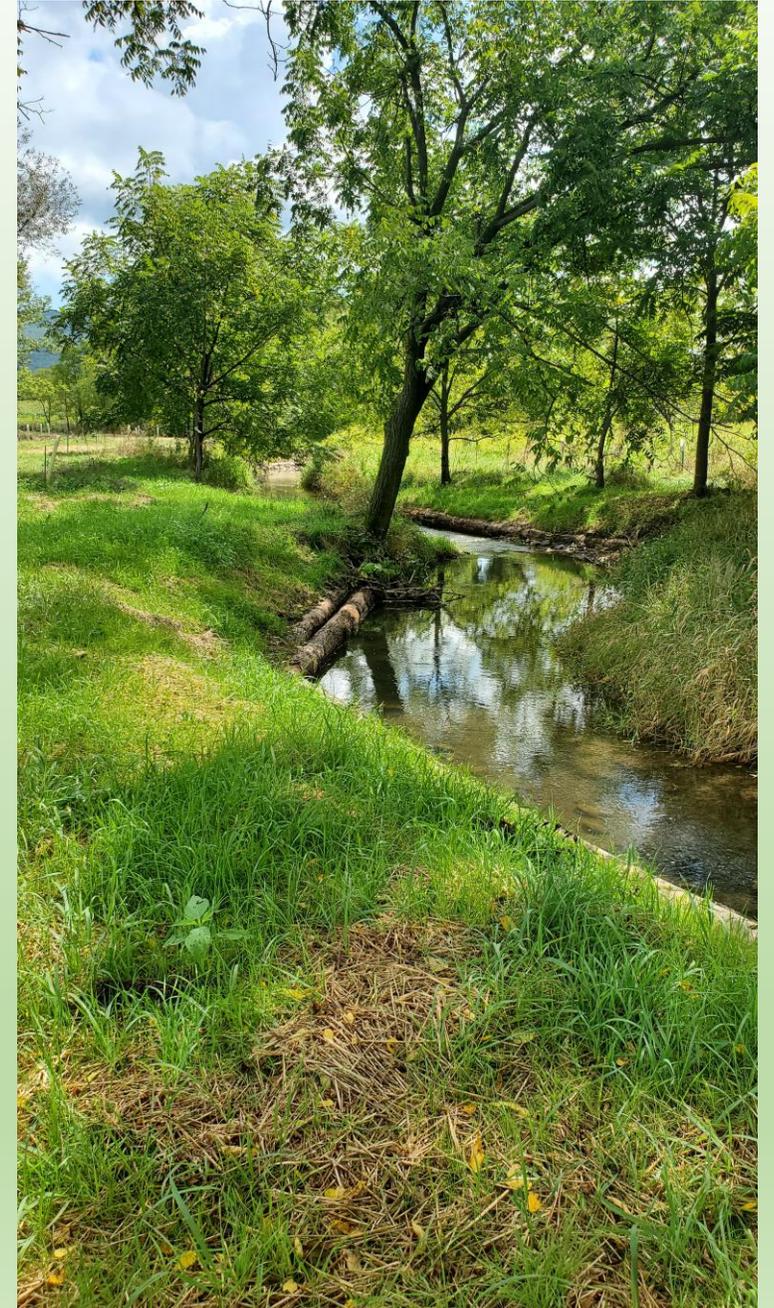
The photo below is the same pool from the previous slide but about two weeks later showing the grass well established in the seeded/mulched areas. The deflector is seen in upper left and the two vanes are viewed from different angle. The photo at right shows the downstream section below the pool with the grass reestablished.

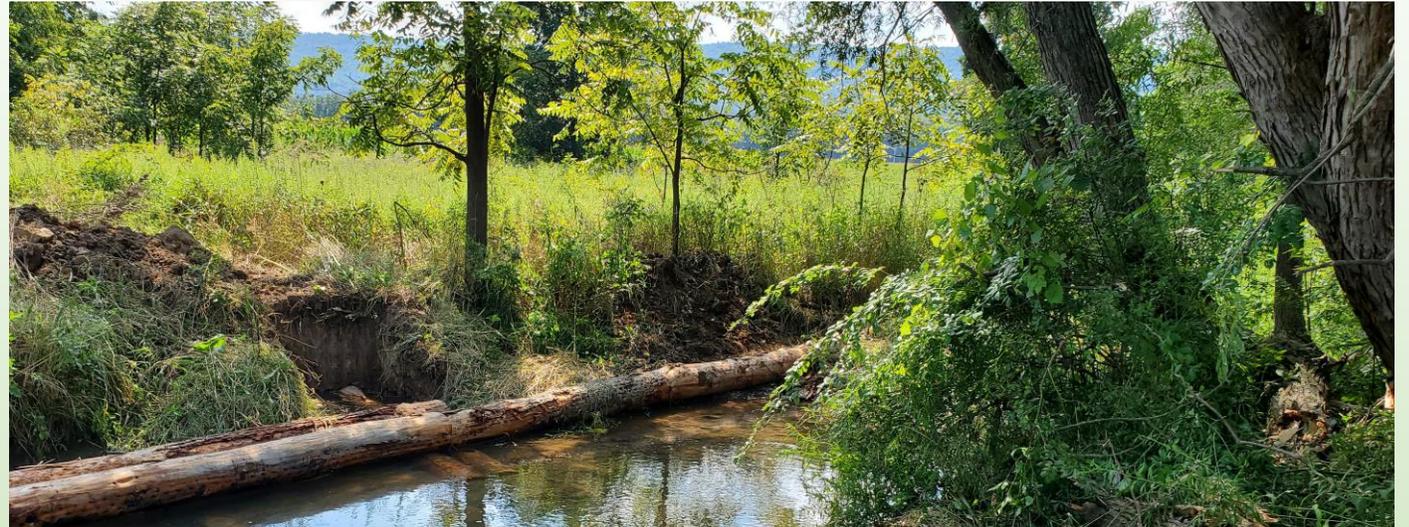
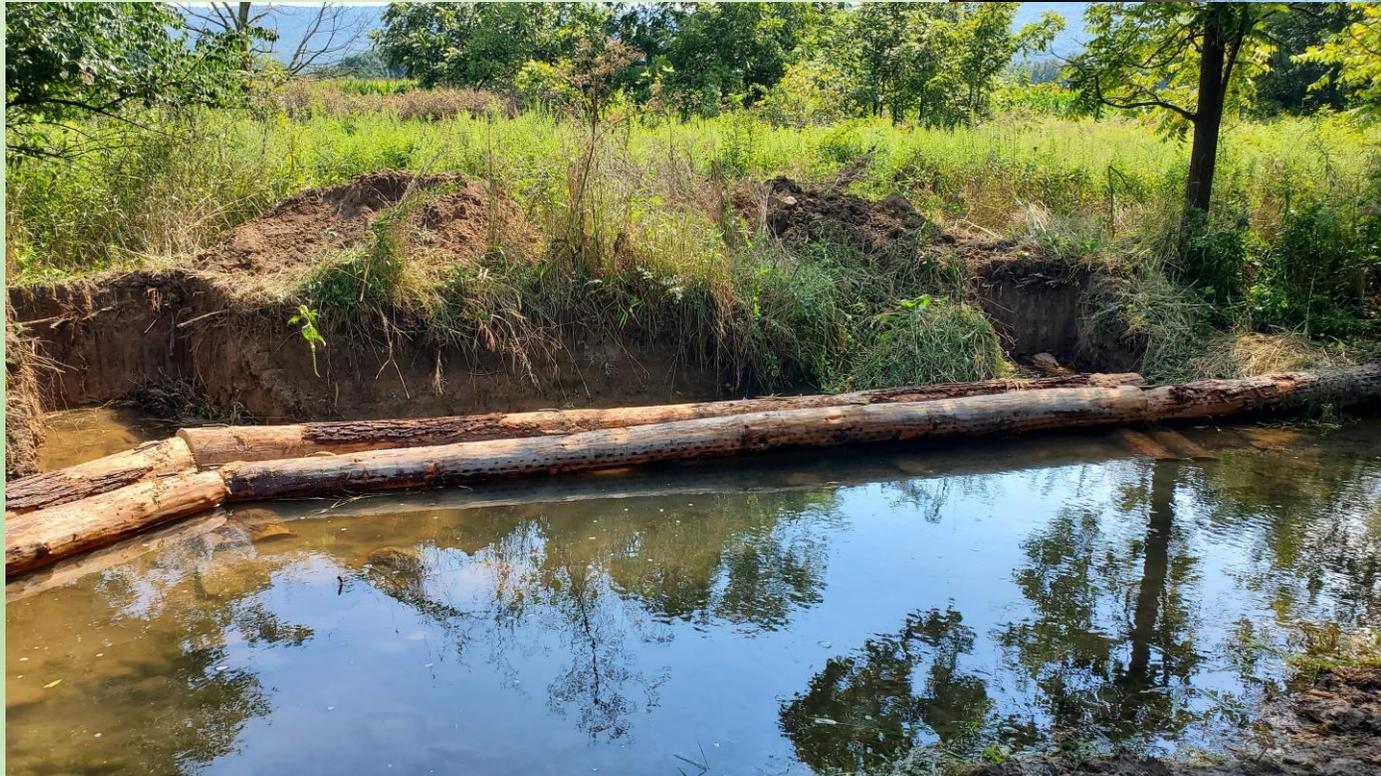
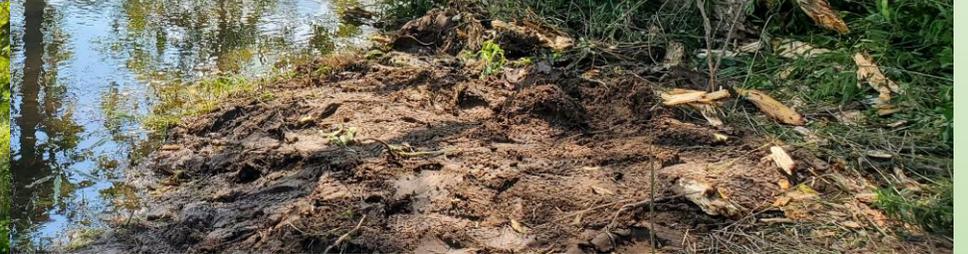
These are some of the photos used in the lower composite panorama in a previous slide, providing clearer view of the sill logs.

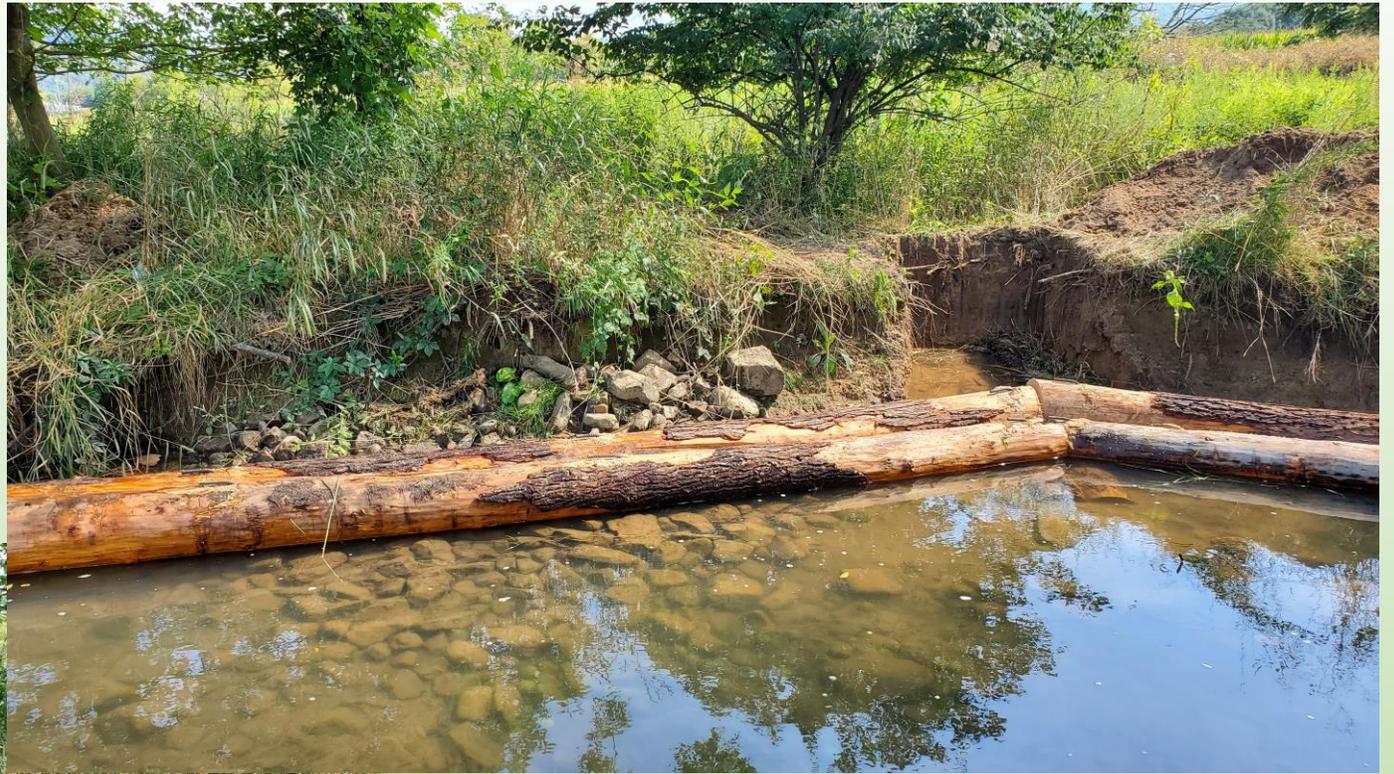
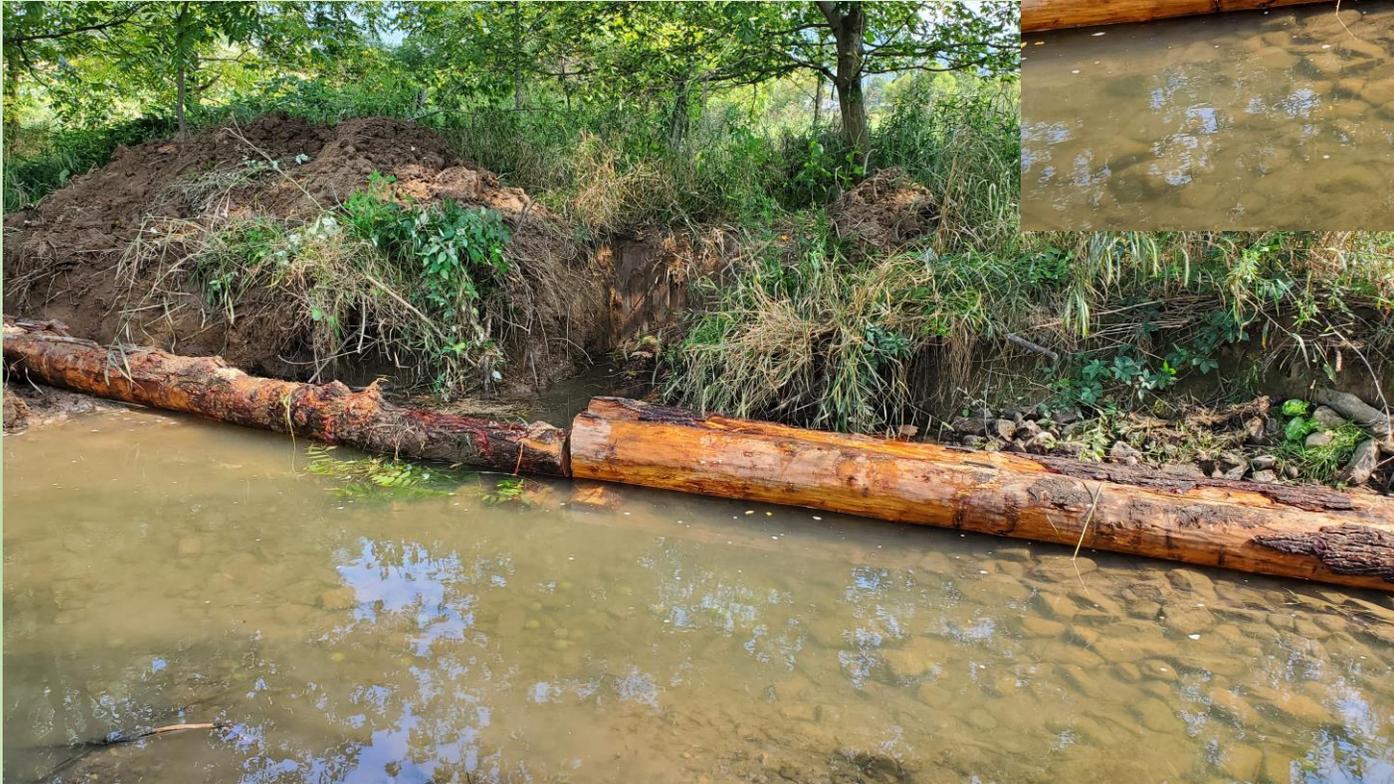
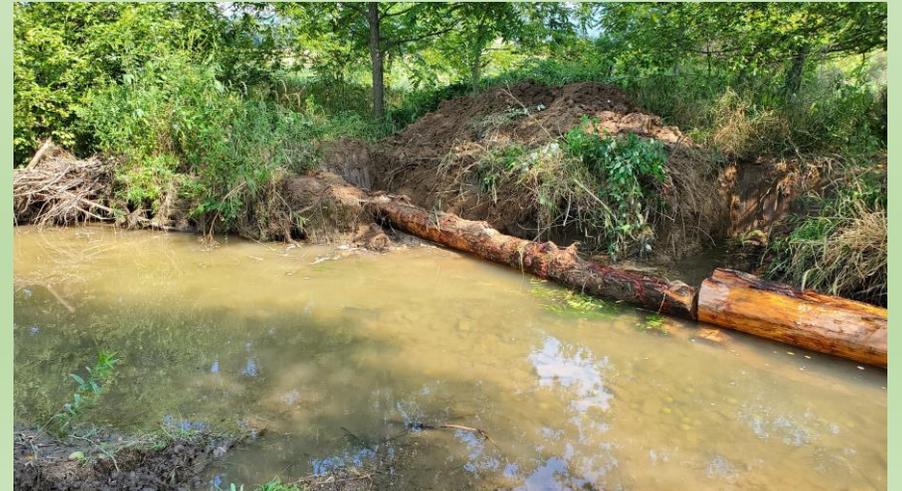
Again, closer views of log assemblage for modified mud-sill.

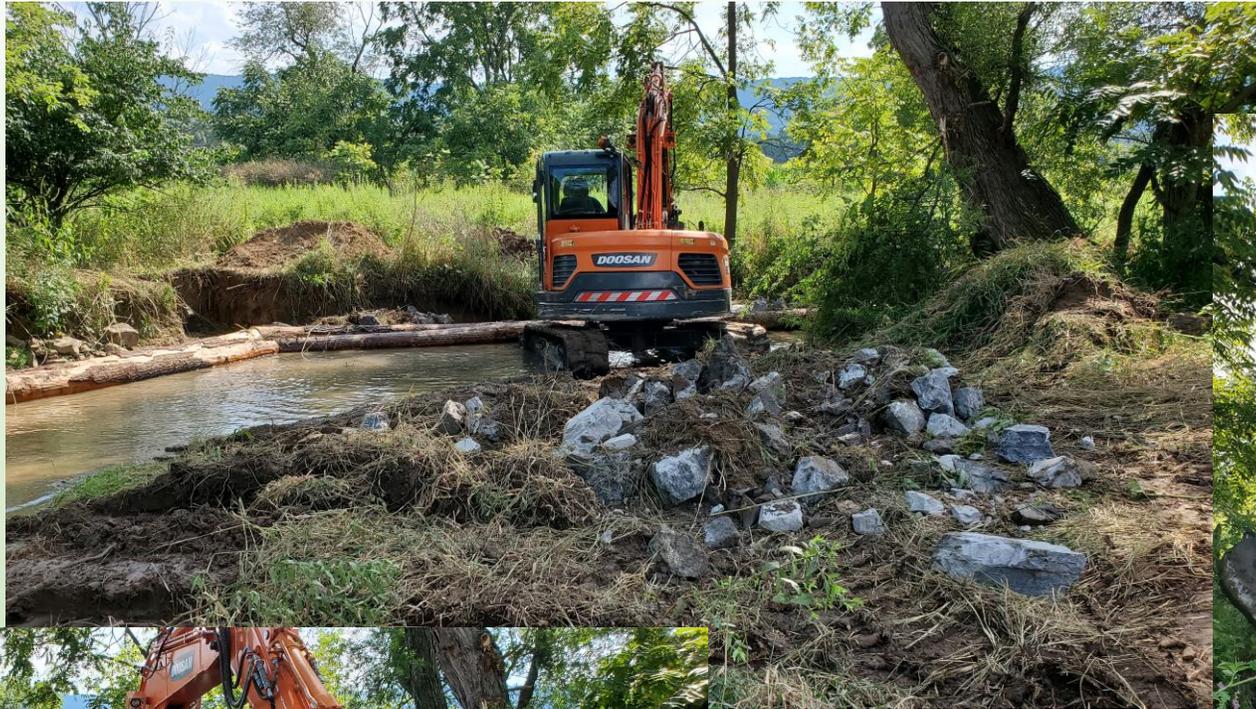
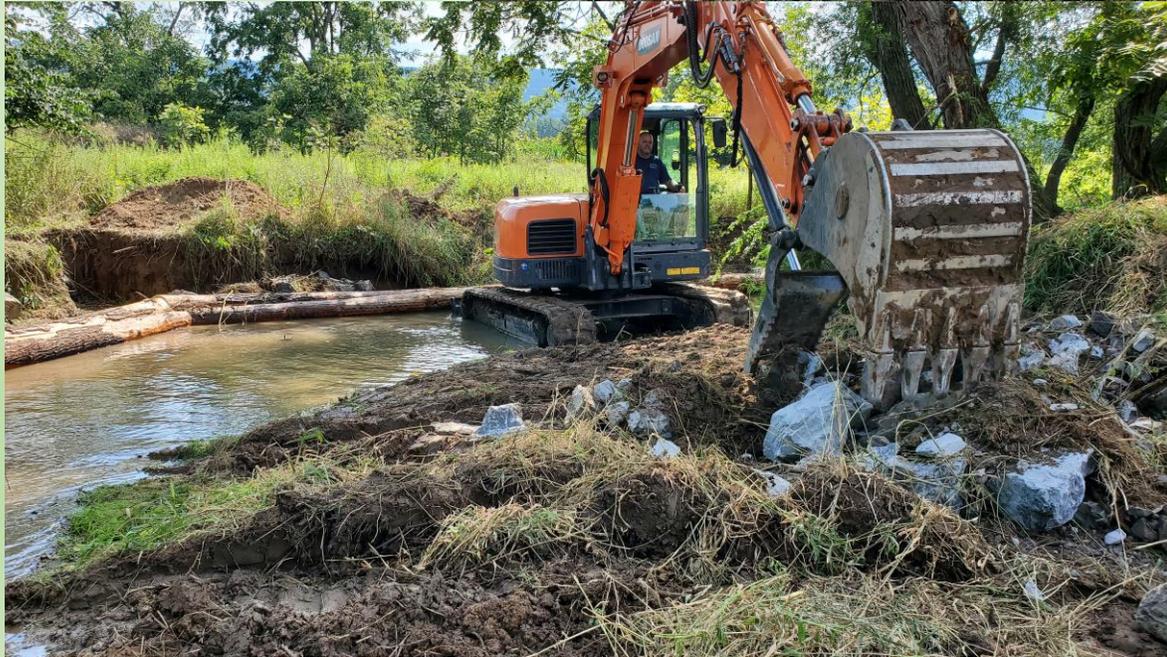
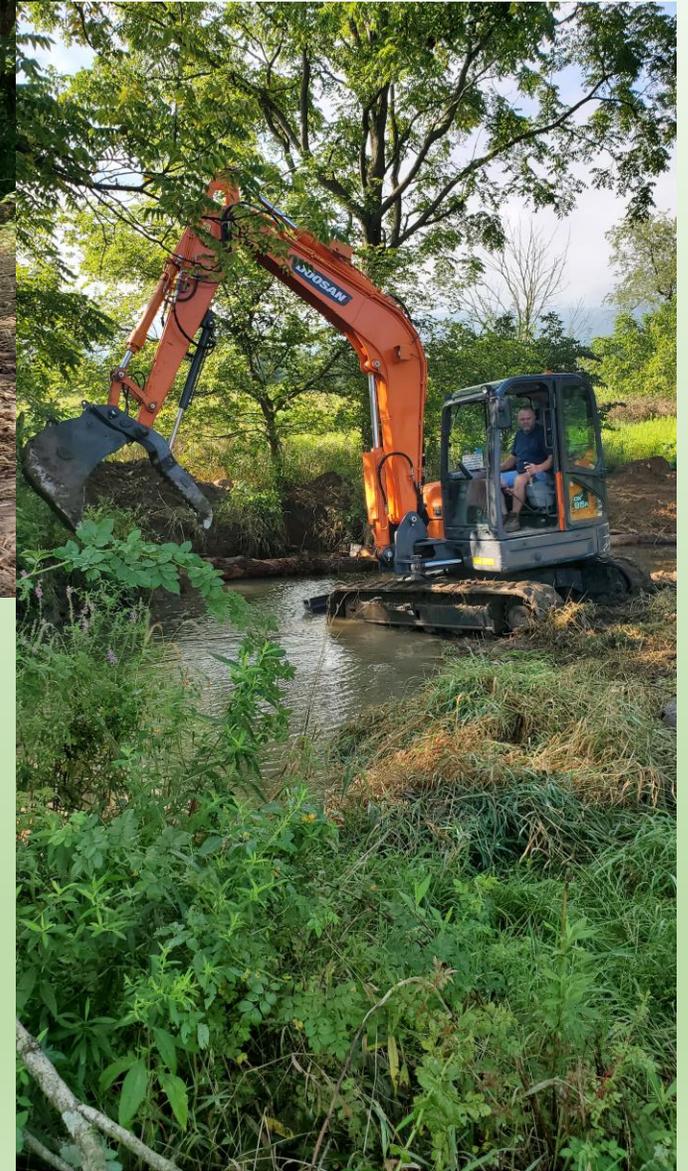
Here the contractor begins placing rock in sill log trenches and behind face logs to stabilize log structure and rebuild bank.

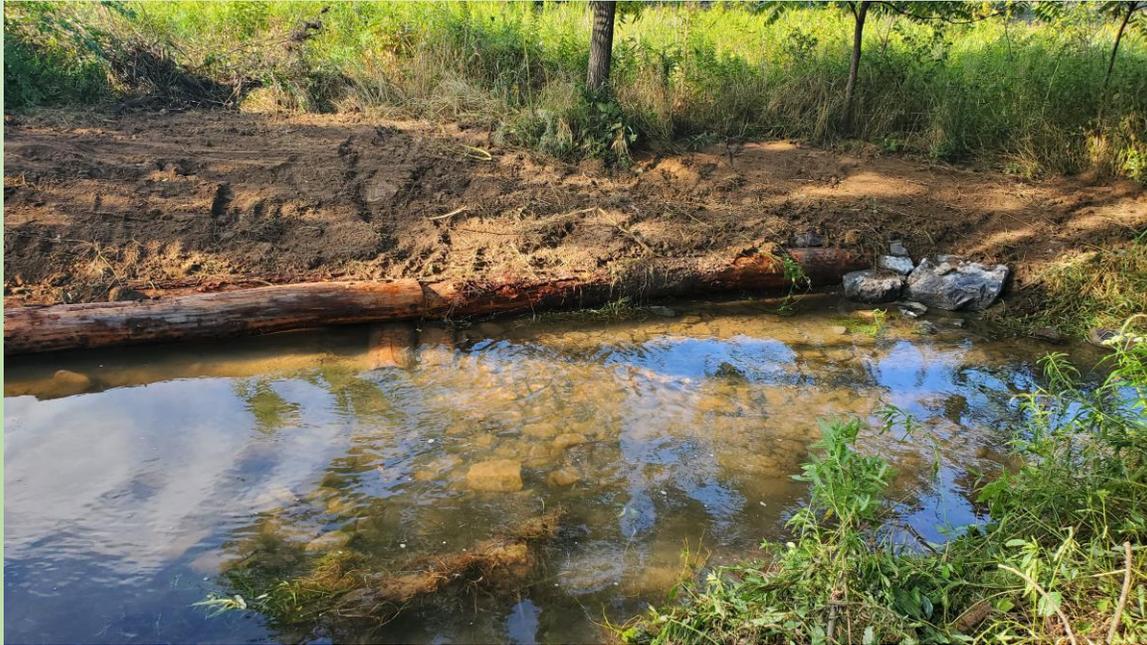
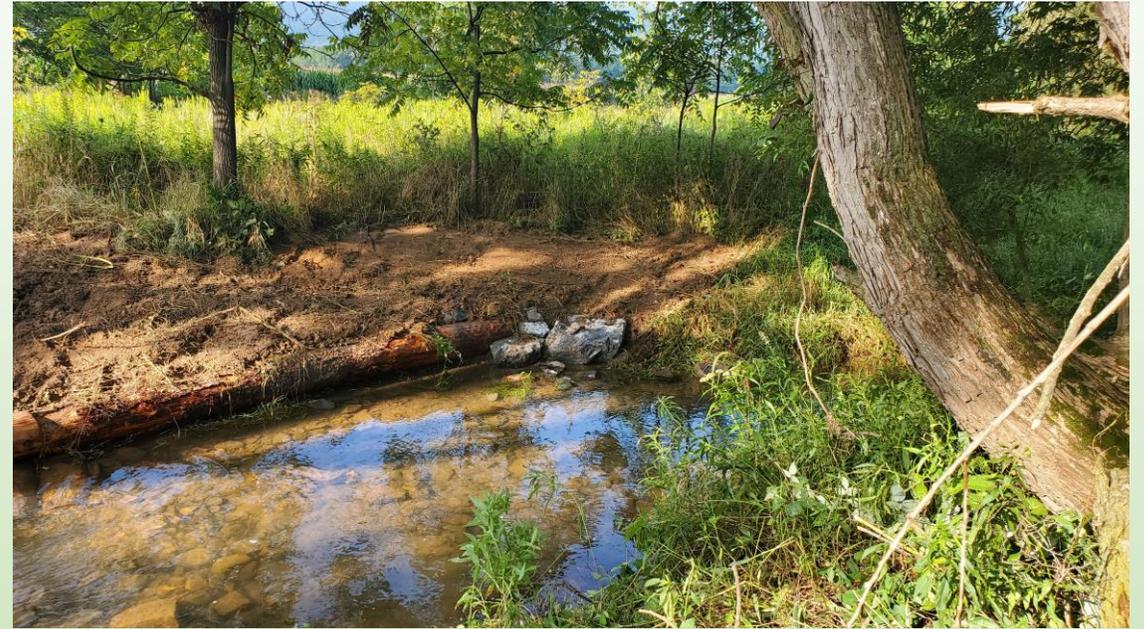
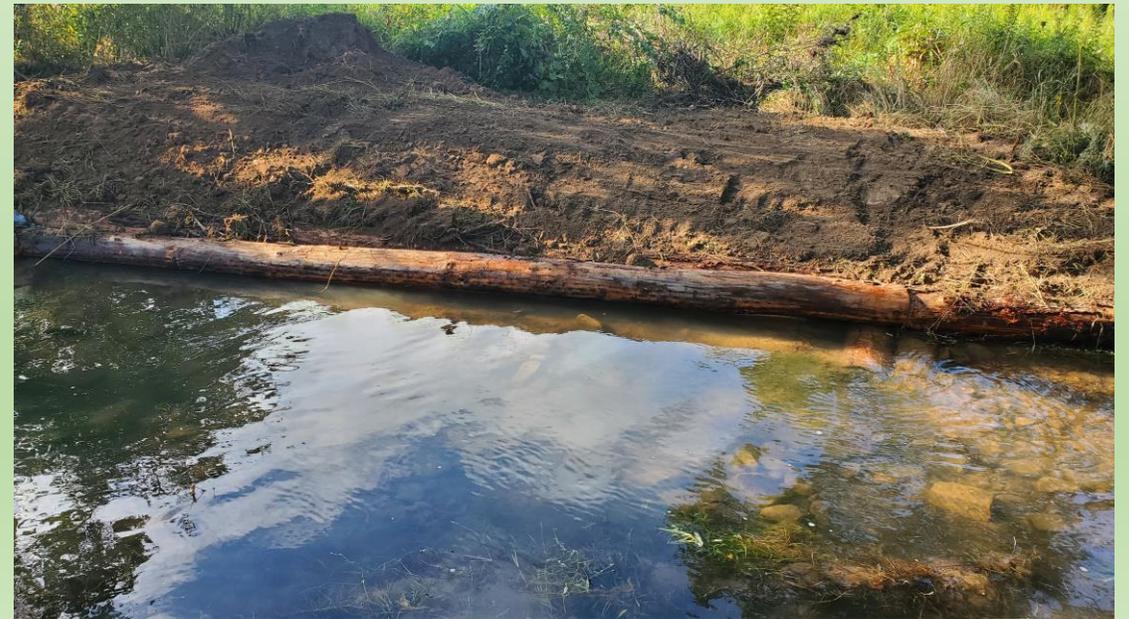
When rock fill is completed, the contractor does a nice job in replacing excavated soil and native stone over the limestone rip-rap, carefully tamping each lift of soil in preparation for seeding and mulching. These areas will also be planted with native trees and shrubs in the spring of 2023 to further restore the riparian buffer area.

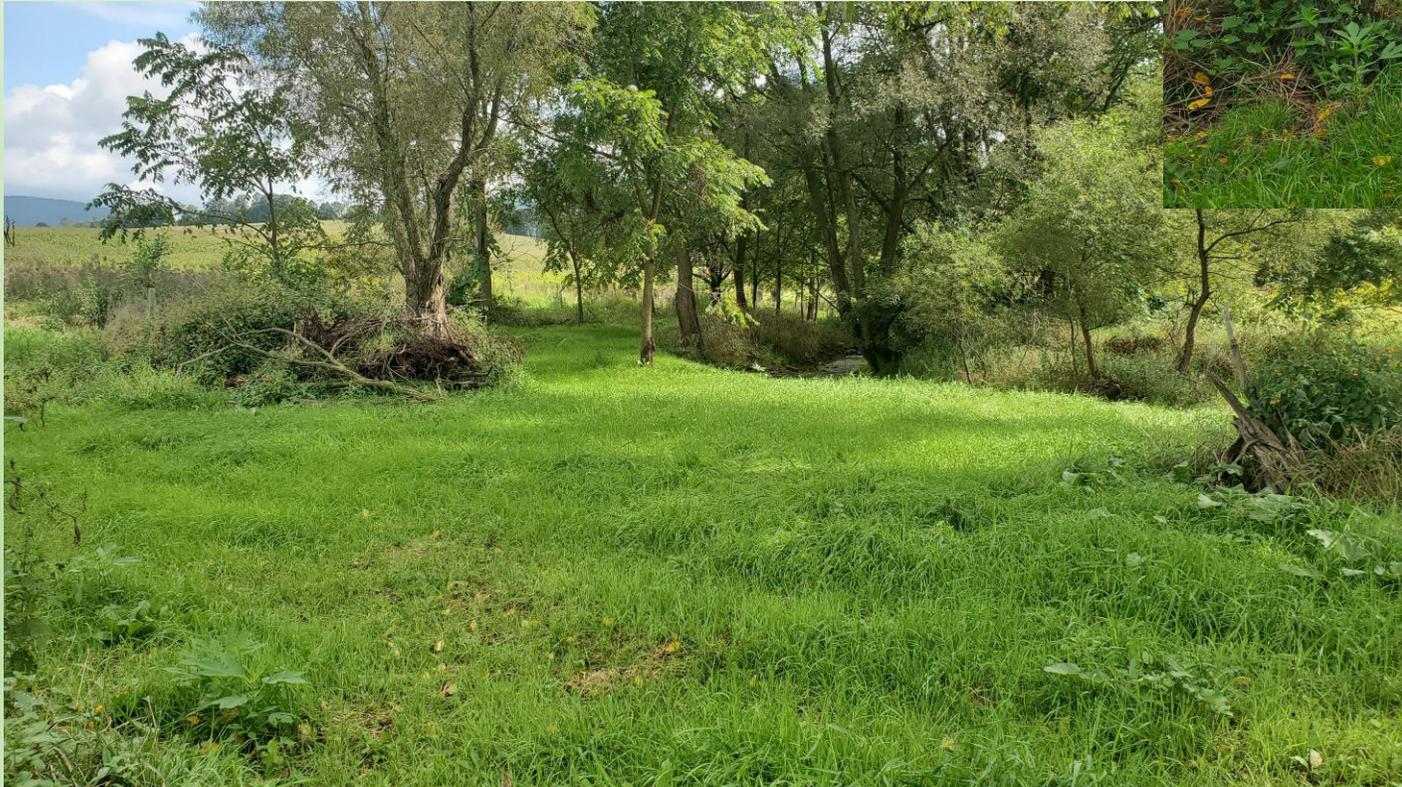
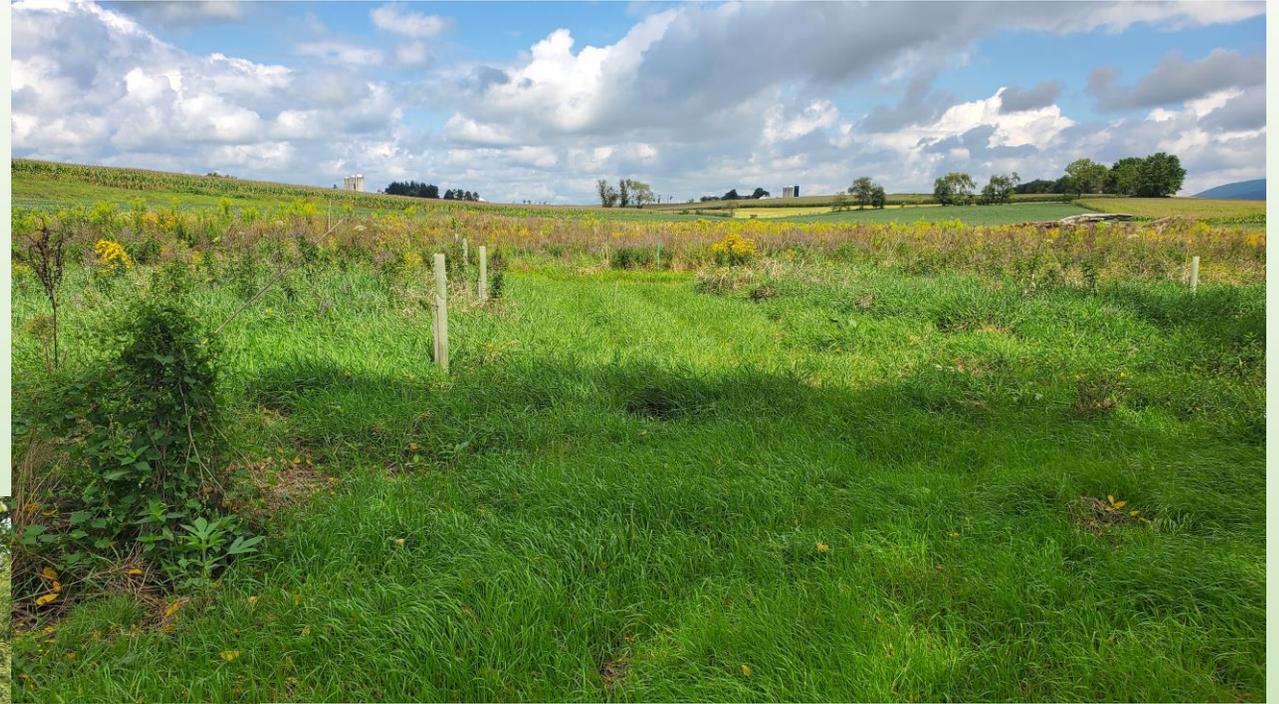
Photo below to illustrate the growth of the planted grass and the 'park-like' nature of the restored areas. On the right is a view in the direction opposite of the stream showing some of riparian buffer adjacent fields and neighboring farms.
