# Beaver Creek Habitat Improvement and Sediment Reduction Project

July - August 2022

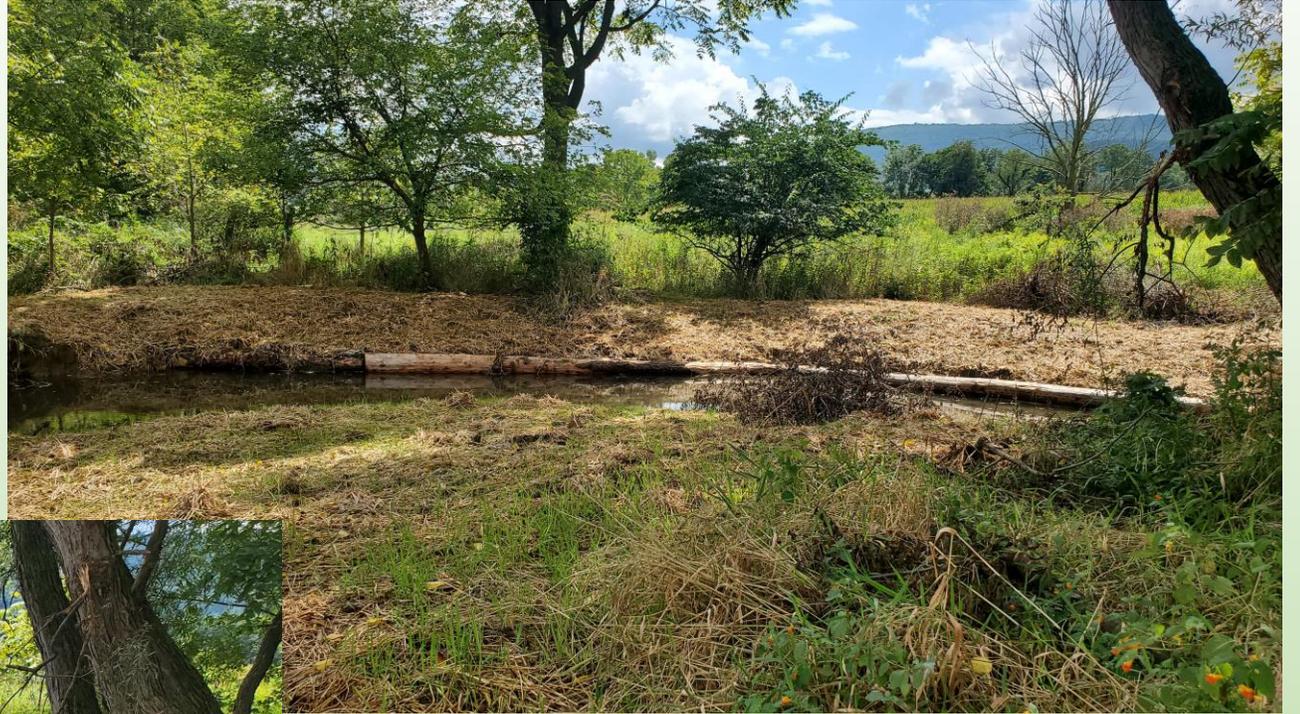
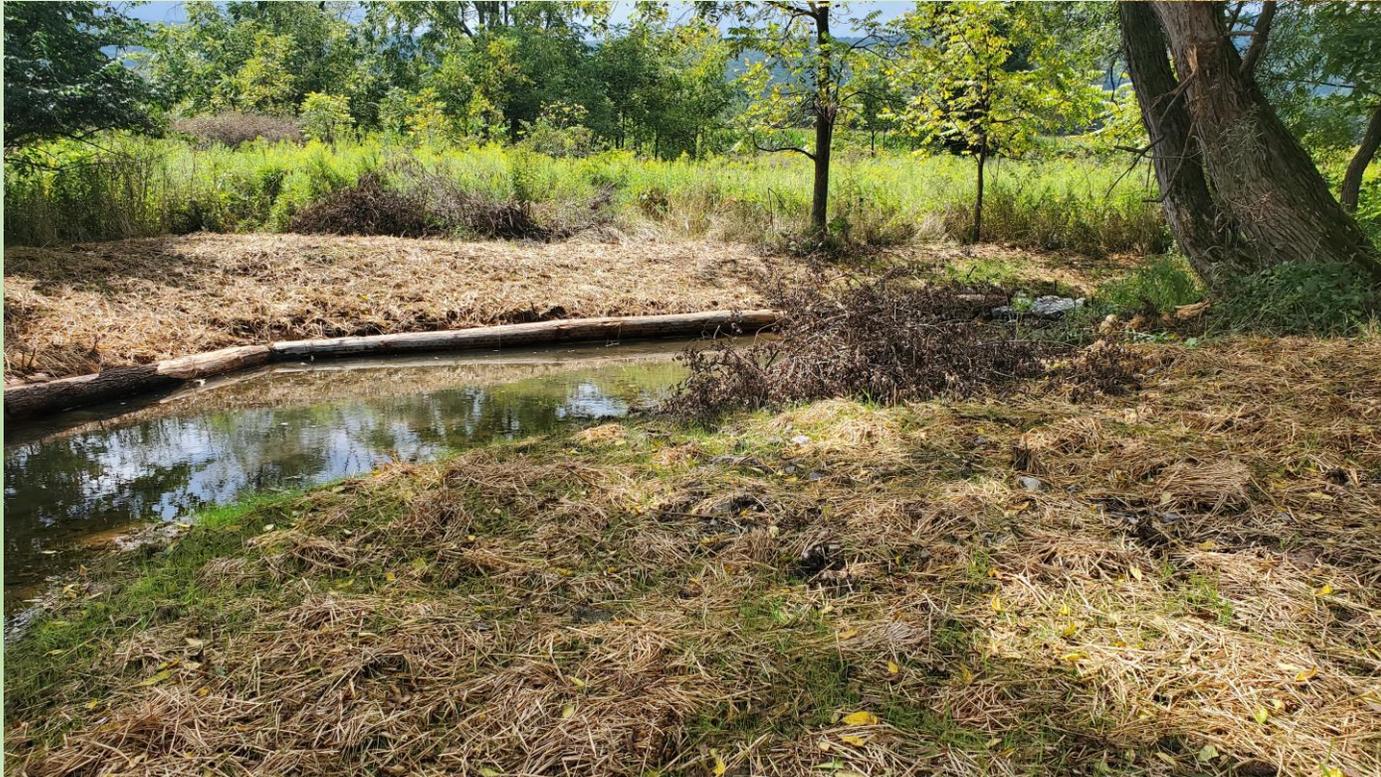
The last big mud-sill with grass just beginning to show.

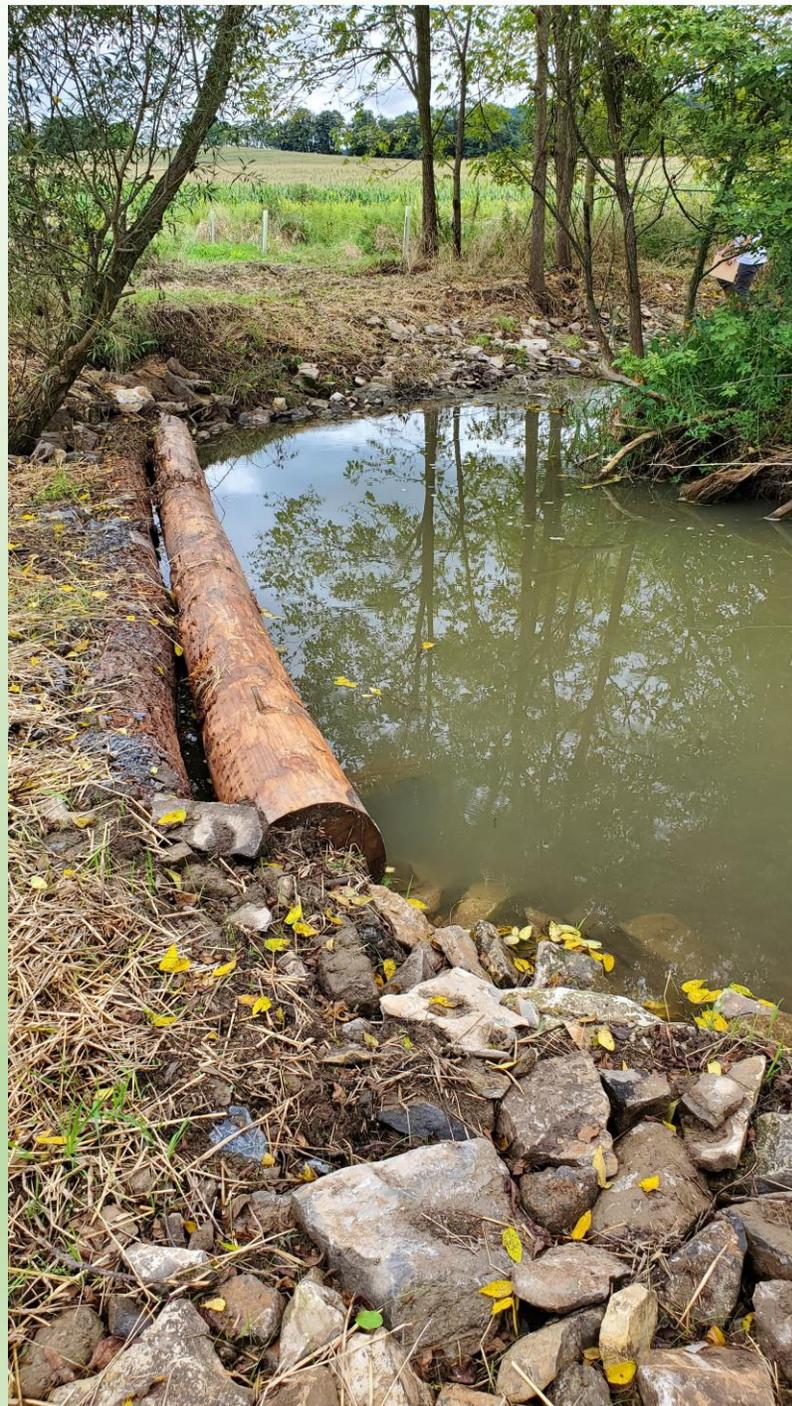
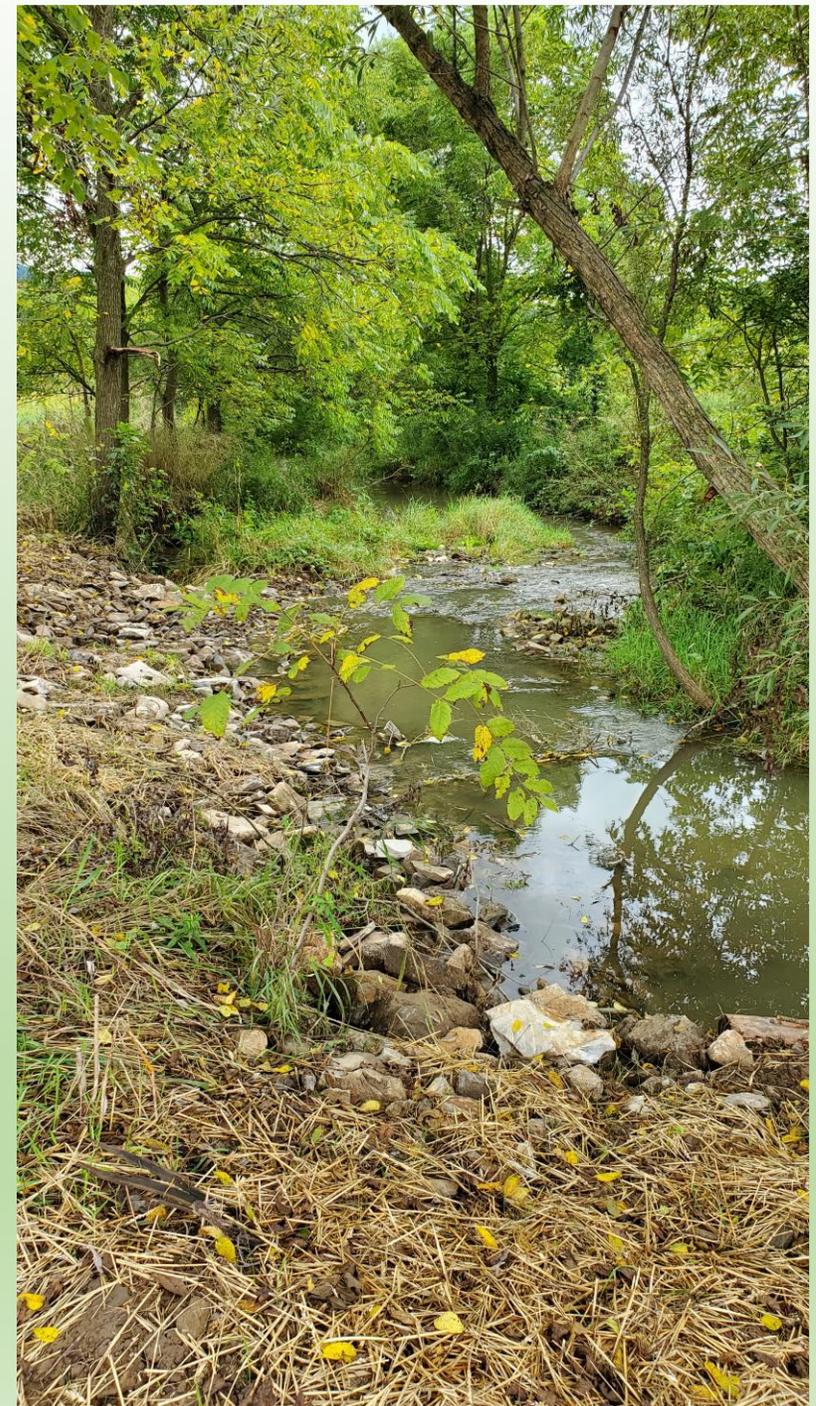
The small mud-sill near the property line and the look around the corner

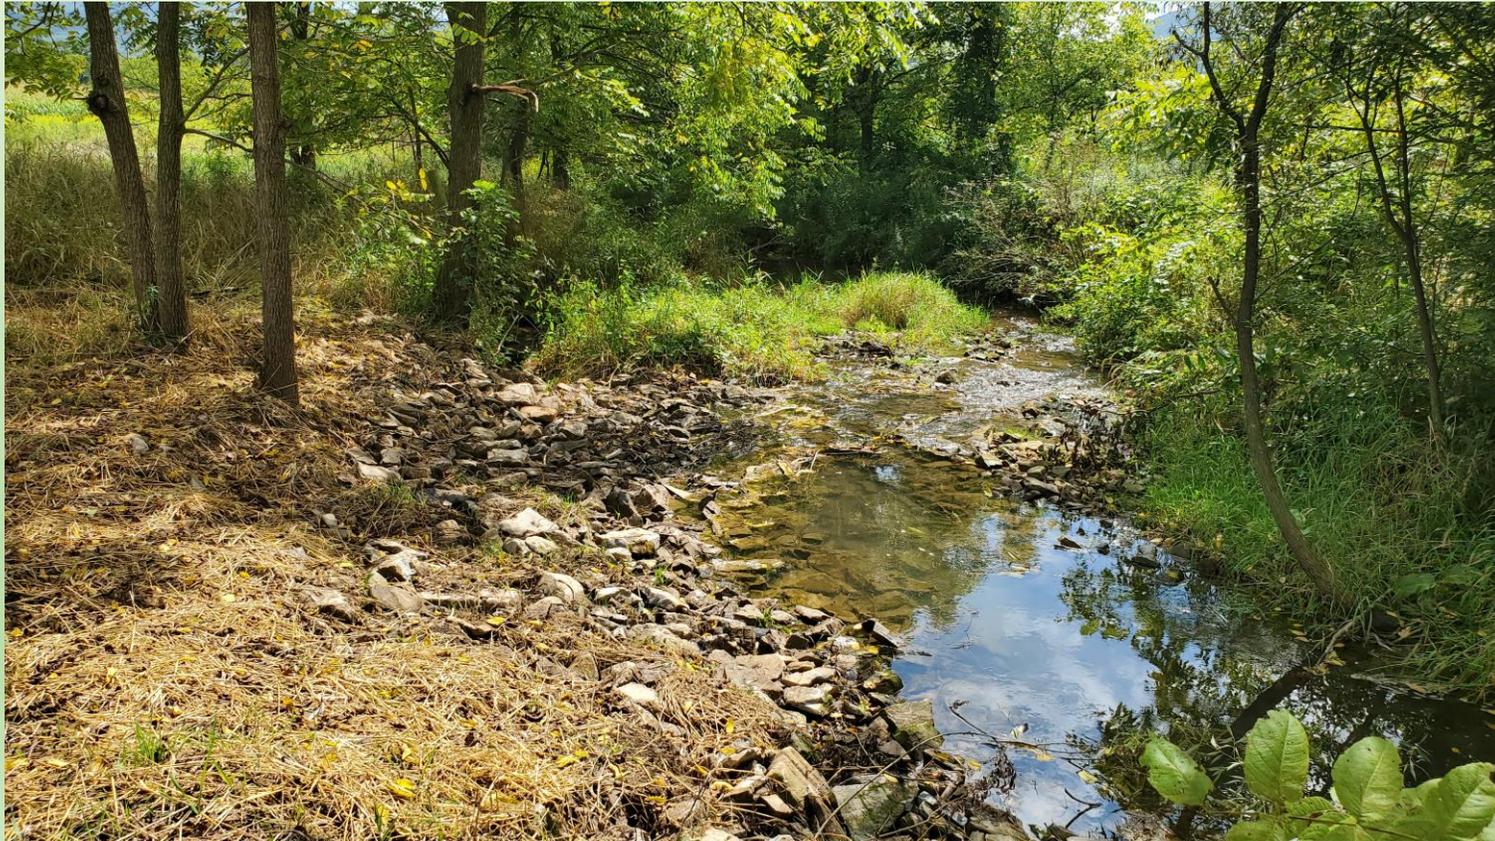
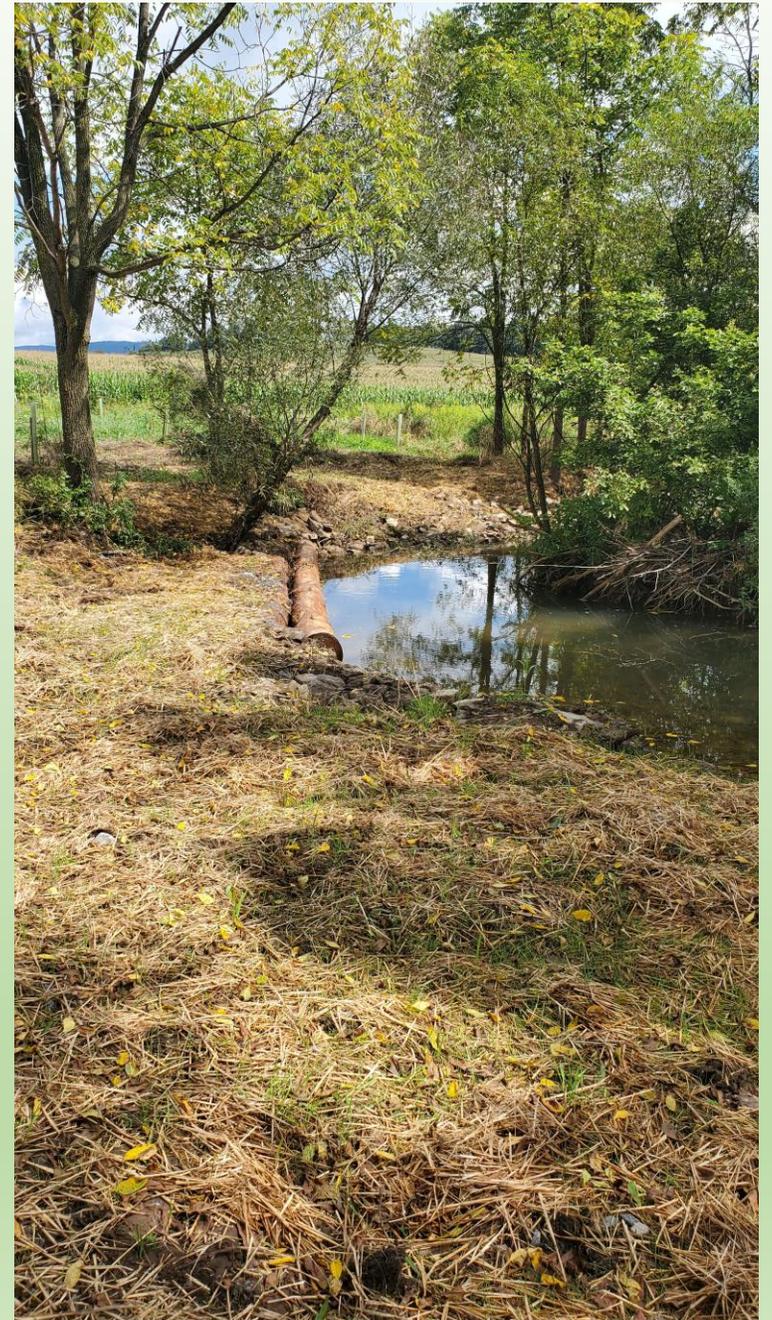
Different views of the last slide subject
